Access Compliance Report

Public Rights-of-Way

(Curb Ramps)

Intersection ID: N/A	Main Street: TAMARACK DR	Cross Street: SINGLELEAF LN	Location: NE
ADA ID: 92C730751DDF	Ramp Type: Perp	Initial Pass/Fail: Pass	Overall Compliance: No
		Severity Score: 0

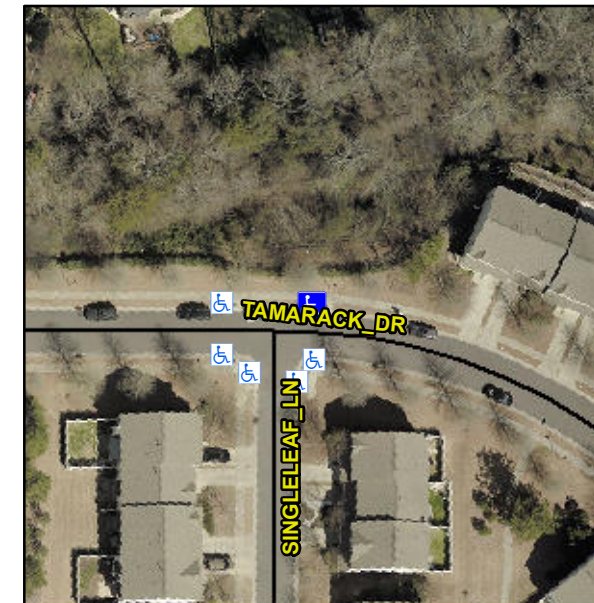
Not Found, R305.2

Compliance	Description	Data	Compliance	Description	Data
N/A	Ramp Length (in)	49.0	Yes	Ramp Slope (%)	6.0
Yes	Ramp Width (in)	48.0	Yes	Ramp XSlope (%)	1.6
N/A	Flare Type LT	Sloped	N/A	Flare Type RT	N/A
N/A	Flare Slope LT (%)	2.9	N/A	Flare Slope RT (%)	4.9
N/A	Flare Traversable LT?	No	N/A	Flare Traversable RT?	No
Yes	Landing Length (in)	48.0	Yes	DWS Provided?	Yes
Yes	Landing Width (in)	48.0	Yes	DWS Contrast?	Yes
Yes	Landing Slope (%)	0.2	Yes	DWS Length (in)	24.0
Yes	Landing X Slope (%)	0.4	Yes	DWS Full Width?	Yes
N/A	Landing Curb? (Y/N)	No	No	DWS Offset (in)	5.5
N/A	Shared Landing?	No			
Yes	Gutter Ponding?	No	Yes	Gutter Slope (%)	0.4
Yes	Gutter Lip Ht (in)	0.0	Yes	Gutter X Slope (%)	0.8
N/A	Painted X Walk1?	No	N/A	Painted X Walk2?	N/A
	X Walk 1 Direction	To S		X Walk 2 Direction	N/A
N/A	X Walk 1 Width (in)	N/A	N/A	X Walk 2 Width (in)	N/A
	X Walk 1 Slope (%)	3.5		X Walk 2 Slope (%)	N/A
	X Walk 1 X Slope (%)	0.1		X Walk 2 X Slope (%)	N/A

N/A	Ramp inside XWalk1?	No	N/A	Ramp inside XWalk2?	N/A
	Road Slope (%)	N/A	N/A	Clear Space?	Yes
	Road X Slope (%)	N/A	N/A	Clear Space to XWalk (in)	N/A
Yes	Any Obstructions?	No	Yes	Storm Grate/Utility Hazard?	No
	Obstruction Type			Storm Grate/Utility Type	
			N/A		N/A
			Yes	Surface Condition? (G/P)	Good

Remove & Replace Entire Ramp.
