# Access Compliance Report

## Public Rights-of-Way

### (Curb Ramps)

| Intersection ID: 10471 | Main Street: CALLAHAN_ST | Cross Street: STATESVILLE_AV | Location: NW |

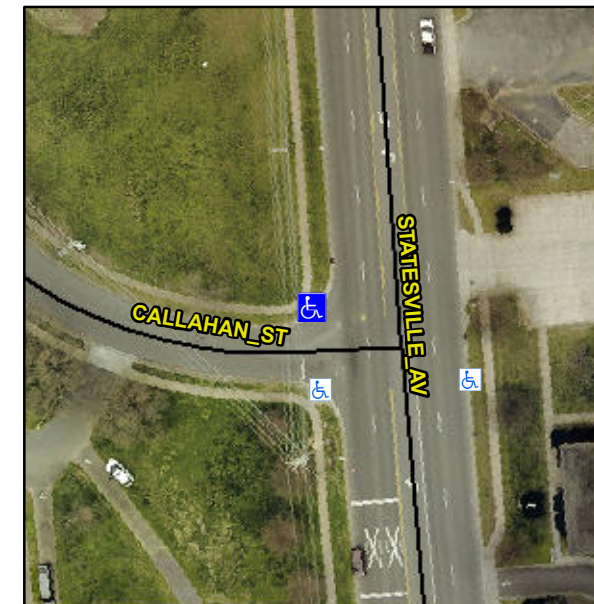
**Not Found, R304.5.3, R304.2.1, R304.2.2-Perp, R304.3.2-Para, R305.2**

| Compliance | Description | Data | Compliance | Description | Data |
|---|---|---|---|---|---|
| Yes | Ramp Width (in) | 48.0 | No | Ramp XSlope (%) | 2.3 |
| No | Landing Width (in) | 47.0 | Yes | DWS Contrast? | Yes |
| No | Landing Slope (%) | 2.1 | Yes | DWS Length (in) | 25.0 |
| N/A | Landing Curb? (Y/N) | No | No | DWS Offset (in) | 6.0 |
| Yes | Gutter Lip Ht (in) | 0.0 | No | Gutter X Slope (%) | 2.3 |

**Remove & Replace Curb Ramp With Two New Directional Ramps or Equivalent. Remove & Replace Gutter.**
