Access Compliance Report

Public Rights-of-Way

(Curb Ramps)

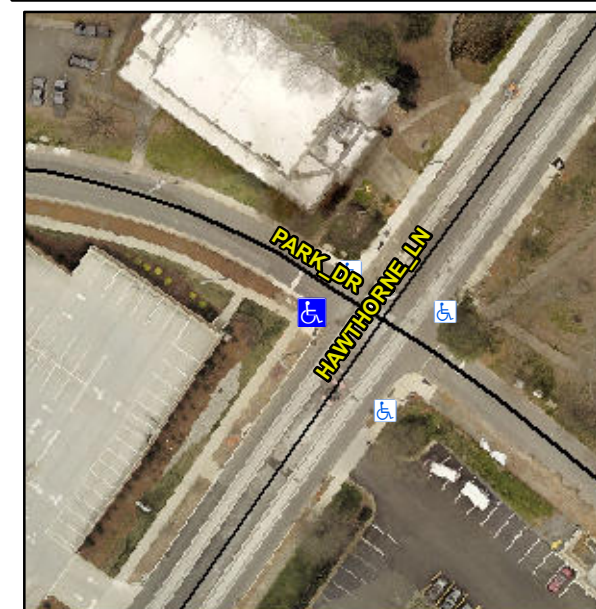
Intersection ID: 13745	Main Street: HAWTHORNE_LN	Cross Street: PARK_DR	Location: W
ADA ID: 92E07A02F2B5	Ramp Type: PerpDiag	Initial Pass/Fail: Fail	Overall Compliance: No
Severity Score: 22.5			
Codes/Mitigation Info/Possible Solution		Field Measurements/Component Compliance

Not Found, R304.5.1, R304.2.2, R304.5.3

Compliance	Description	Data	Compliance	Description	Data
N/A	Ramp Length (in)	74.0	No	Ramp Slope (%)	8.8
No	Ramp Width (in)	47.0	No	Ramp XSlope (%)	4.7
N/A	Flare Type LT	N/A	N/A	Flare Type RT	N/A
N/A	Flare Slope LT (%)	N/A	N/A	Flare Slope RT (%)	N/A
N/A	Flare Traversable LT?	N/A	N/A	Flare Traversable RT?	N/A
N/A	Landing Length (in)	N/A	N/A	DWS Provided?	N/A
N/A	Landing Width (in)	N/A	N/A	DWS Contrast?	N/A
N/A	Landing Slope (%)	N/A	N/A	DWS Length (in)	N/A
N/A	Landing X Slope (%)	N/A	N/A	DWS Full Width?	N/A
N/A	Landing Curb? (Y/N)	N/A	N/A	DWS Offset (in)	N/A
N/A	Shared Landing?	N/A			
N/A	Gutter Ponding?	N/A	N/A	Gutter Slope (%)	N/A
N/A	Gutter Lip Ht (in)	N/A	N/A	Gutter X Slope (%)	N/A
N/A	Painted X Walk1?	No	N/A	Painted X Walk2?	Yes
	X Walk 1 Direction	To SE		X Walk 2 Direction	To NE
N/A	X Walk 1 Width (in)	N/A	N/A	X Walk 2 Width (in)	87.0
	X Walk 1 Slope (%)	4.3		X Walk 2 Slope (%)	1.7
	X Walk 1 X Slope (%)	2.0		X Walk 2 X Slope (%)	1.4

N/A	Ramp inside XWalk1?	N/A	N/A	Ramp inside XWalk2?	Yes
	Road Slope (%)	0.0	N/A	Clear Space?	N/A
	Road X Slope (%)	0.8	N/A	Clear Space to XWalk (in)	N/A
N/A	Any Obstructions?	N/A	N/A	Storm Grate/Utility Hazard?	N/A
	Obstruction Type			Storm Grate/Utility Type	
		N/A			N/A
			Yes	Surface Condition? (G/P)	Good

Remove & Replace Curb Ramp With Two New Directional Ramps or Equivalent.

Total Cost: \$ 3200.00
