Access Compliance Report

Public Rights-of-Way

(Curb Ramps)

Intersection ID: 6687	Main Street: NEVIN_RD	Cross Street: KAYRON_DR	Location: NE
ADA ID: 92F92AAD8487	Ramp Type: Directional1	Initial Pass/Fail: Fail	Overall Compliance: No
		Severity Score: 12.5

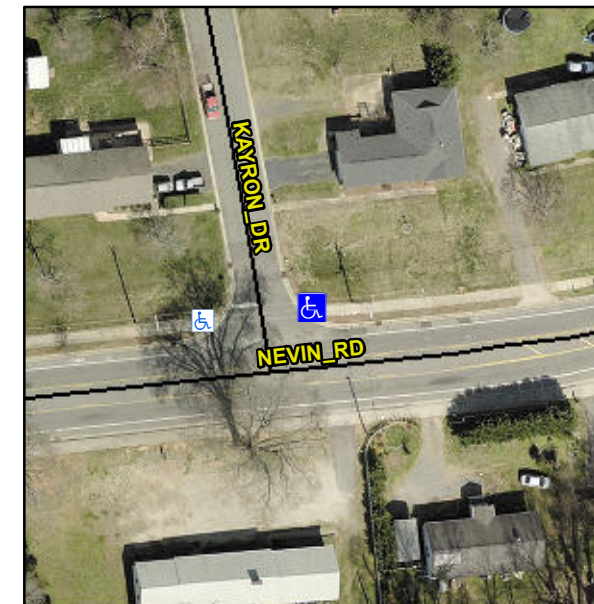
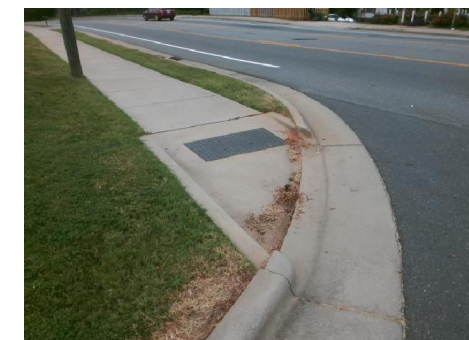
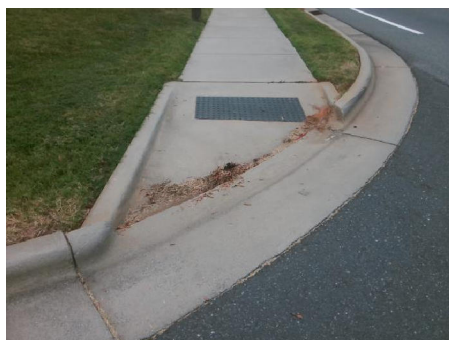
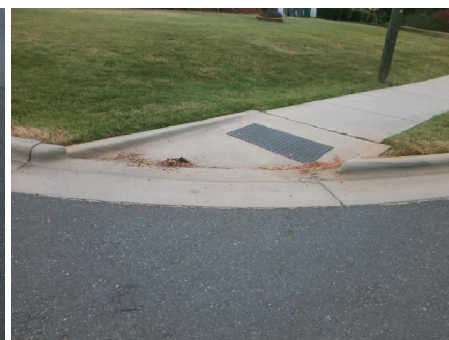
R304.5.3

Compliance	Description	Data	Compliance	Description	Data
N/A	Ramp Length (in)	32.0	N/A	Grade Break?	N/A
Yes	Ramp Width (in)	72.0	N/A	Grade Break Slope (%)	0.0
Yes	Ramp Slope (%)	7.7	N/A	Grade Break XSlope (%)	0.0
No	Ramp XSlope (%)	6.2			
N/A	Flare Type LT	N/A	N/A	Flare Type RT	N/A
N/A	Flare Slope LT (%)	N/A	N/A	Flare Slope RT (%)	0.0
N/A	Flare Traversable LT?	N/A	N/A	Flare Traversable RT?	N/A
N/A	Landing Length (in)	0.0	N/A	DWS Provided?	N/A
N/A	Landing Width (in)	0.0	N/A	DWS Contrast?	N/A
N/A	Landing Slope (%)	0.0	N/A	DWS Length (in)	N/A
N/A	Landing X Slope (%)	0.0	N/A	DWS Full Width?	N/A
N/A	Landing Curb? (Y/N)	N/A	N/A	DWS Offset LT (in)	N/A
N/A	Shared Landing?	N/A	N/A	DWS Offset RT (in)	N/A
N/A	Gutter Ponding?	0.0	N/A	Gutter Slope (%)	N/A
N/A	Gutter Lip Ht (in)	3.0	N/A	Gutter X Slope (%)	N/A
N/A	Painted X Walk1?	No		Road Slope (%)	4.8
	X Walk 1 Direction	To W		Road X Slope (%)	6.3
	X Walk 1 Width (in)	N/A		Clear Space?	N/A

X Walk 1 Slope (%)	4.8	N/A	Clear Space to XWalk (in)	N/A
	X Walk 1 X Slope (%)	6.3	N/A	Storm Grate/Utility Hazard?	N/A
N/A	Ramp inside XWalk1?	N/A		Storm Grate/Utility Type	
N/A	Any Obstructions?	N/A			N/A
	Obstruction Type		Yes	Surface Condition? (G/P)	Good
			N/A	Curb Slope (%)	8.1

Remove & Replace Entire Ramp.

\$ 1600.00
