# Access Compliance Report

## Public Rights-of-Way

### (Curb Ramps)

| Intersection ID: N/A | Main Street: PROVIDENCE_RD | Cross Street: OXFORD_PL | Location: E |

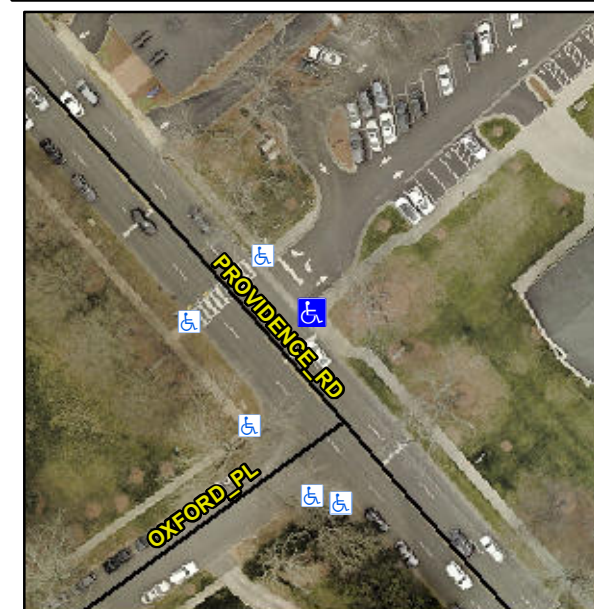
**Not Found, R304.5.3, R304.2.1, R304.2.2-Perp, R304.3.2-Para, R305.2**

| Compliance | Description | Data | Compliance | Description | Data |
|---|---|---|---|---|---|
| Yes | Ramp Width (in) | 50.0 | No | Ramp XSlope (%) | 3.8 |
| No | Landing Length (in) | N/A | Yes | DWS Provided? | Yes |
| No | Landing Width (in) | N/A | Yes | DWS Contrast? | Yes |
| No | Landing Slope (%) | N/A | Yes | DWS Length (in) | 24.0 |
| No | Landing X Slope (%) | N/A | Yes | DWS Full Width? | Yes |
| N/A | Landing Curb? (Y/N) | No | No | DWS Offset (in) | 3.0 |
| Yes | Gutter Lip Ht (in) | 0.0 | No | Gutter X Slope (%) | 2.2 |

Possible Solutions:

**Remove & Replace Curb Ramp With Two New Directional Ramps or Equivalent. Remove & Replace Gutter.**
