# Access Compliance Report

## Public Rights-of-Way

### (Curb Ramps)

Intersection ID: 8925	Main Street: E_W_T_HARRIS_BV	Cross Street: THE_PLAZA	Location: SE
ADA ID: 92FCDFDC2C5C	Ramp Type: Para	Initial Pass/Fail: Pass	Overall Compliance: No
		Severity Score: 7.75

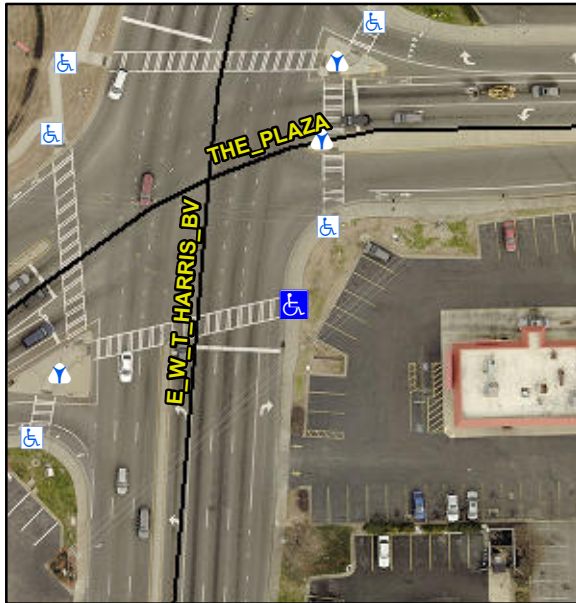
**R304.5.3, R304.2.2-Perp, R304.3.2-  
Para, R305.2, R302.7, R302.7.2**

Compliance	Description	Data	Compliance	Description	Data
N/A	Ramp Length LT (in)	74.0	N/A	Ramp Length RT (in)	70.0
Yes	Ramp Width LT (in)	82.5	Yes	Ramp Width RT (in)	82.5
Yes	Ramp Slope LT (%)	6.8	Yes	Ramp Slope RT (%)	6.8
No	Ramp XSlope LT (%)	2.1	No	Ramp XSlope RT (%)	2.5
Yes	Landing Length (in)	82.5	Yes	DWS Provided?	Yes
Yes	Landing Width (in)	48.0	Yes	DWS Contrast?	Yes
No	Landing Slope (%)	2.6	Yes	DWS Length (in)	24.0
Yes	Landing X Slope (%)	0.9	Yes	DWS Full Width?	Yes
N/A	Landing Curb? (Y/N)	No	No	DWS Offset (in)	2.5
N/A	Shared Landing?	No			
No	Gutter Ponding?	Yes	Yes	Gutter Slope (%)	2.1
No	Gutter Lip Ht (in)	0.5	Yes	Gutter X Slope (%)	0.6
N/A	Painted X Walk1?	Yes	N/A	Painted X Walk2?	N/A
	X Walk 1 Direction	To SW		X Walk 2 Direction	N/A
N/A	X Walk 1 Width (in)	114.0	N/A	X Walk 2 Width (in)	N/A
	X Walk 1 Slope (%)	3.4		X Walk 2 Slope (%)	N/A
	X Walk 1 X Slope (%)	0.7		X Walk 2 X Slope (%)	N/A
Yes	Ramp inside XWalk1?	Yes	N/A	Ramp inside XWalk2?	N/A

Road Slope (%)	N/A	N/A	Clear Space?	Yes
	Road X Slope (%)	N/A	N/A	Clear Space to XWalk (in)	N/A
Yes	Any Obstructions?	No	Yes	Storm Grate/Utility Hazard?	No
	Obstruction Type			Storm Grate/Utility Type	
		N/A			N/A
			Yes	Surface Condition? (G/P)	Good
			N/A	Curb Slope (%)	5.5

**Remove & Replace Entire Ramp.  
Grind Gutter Lip.**
