# Access Compliance Report

## Public Rights-of-Way

### (Curb Ramps)

Intersection ID: 49235	Main Street: NEW_CALVINE_ST	Cross Street: N_CALDWELL_ST	Location: N
ADA ID: 93035114055F	Ramp Type: Perp	Initial Pass/Fail: Fail	Overall Compliance: No
Severity Score: 13.75			
Codes/Mitigation Info/Possible Solution		Field Measurements/Component Compliance

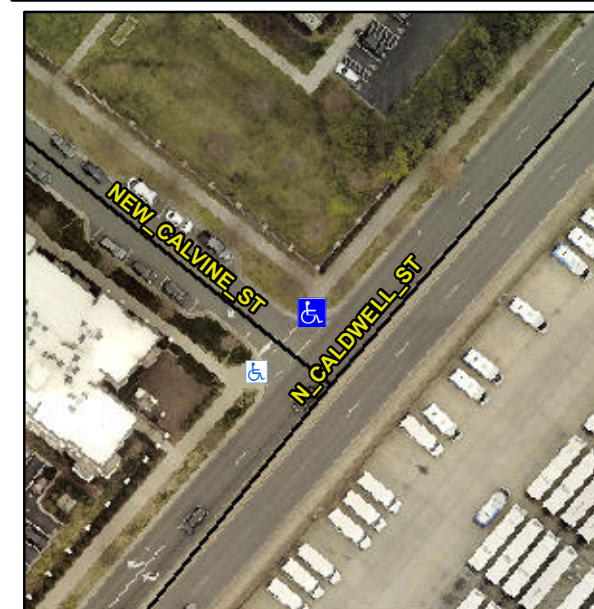
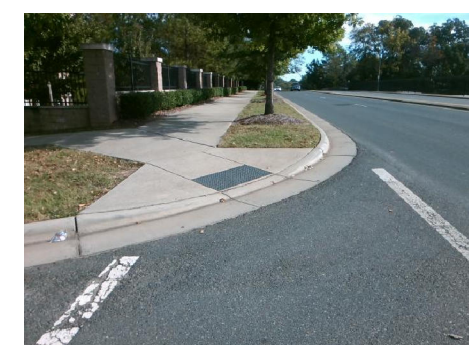
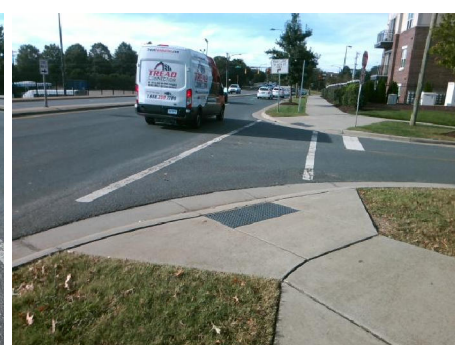
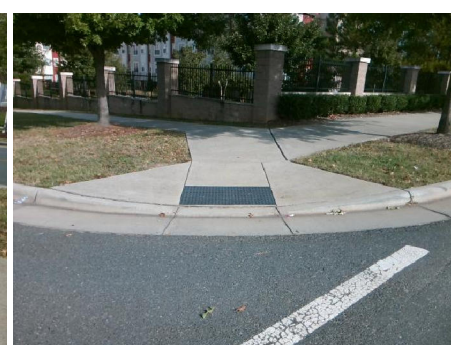
**Not Found, R304.2.2, R304.5.3**

Compliance	Description	Data	Compliance	Description	Data
N/A	Ramp Length (in)	73.0	No	Ramp Slope (%)	9.1
Yes	Ramp Width (in)	48.0	No	Ramp XSlope (%)	2.6
N/A	Flare Type LT	N/A	N/A	Flare Type RT	N/A
N/A	Flare Slope LT (%)	N/A	N/A	Flare Slope RT (%)	N/A
N/A	Flare Traversable LT?	N/A	N/A	Flare Traversable RT?	N/A
N/A	Landing Length (in)	N/A	N/A	DWS Provided?	N/A
N/A	Landing Width (in)	N/A	N/A	DWS Contrast?	N/A
N/A	Landing Slope (%)	N/A	N/A	DWS Length (in)	N/A
N/A	Landing X Slope (%)	N/A	N/A	DWS Full Width?	N/A
N/A	Landing Curb? (Y/N)	N/A	N/A	DWS Offset (in)	N/A
N/A	Shared Landing?	N/A			
N/A	Gutter Ponding?	N/A	N/A	Gutter Slope (%)	N/A
N/A	Gutter Lip Ht (in)	N/A	N/A	Gutter X Slope (%)	N/A
N/A	Painted X Walk1?	Yes	N/A	Painted X Walk2?	N/A
	X Walk 1 Direction	To SW		X Walk 2 Direction	N/A
N/A	X Walk 1 Width (in)	108.0	N/A	X Walk 2 Width (in)	N/A
	X Walk 1 Slope (%)	0.6		X Walk 2 Slope (%)	N/A
	X Walk 1 X Slope (%)	5.1		X Walk 2 X Slope (%)	N/A

N/A	Ramp inside XWalk1?	Yes	N/A	Ramp inside XWalk2?	N/A
	Road Slope (%)	N/A	N/A	Clear Space?	N/A
	Road X Slope (%)	N/A	N/A	Clear Space to XWalk (in)	N/A
N/A	Any Obstructions?	N/A	N/A	Storm Grate/Utility Hazard?	N/A
	Obstruction Type			Storm Grate/Utility Type	
		N/A			N/A
		Yes		Surface Condition? (G/P)	Good

Possible Solutions:

**Remove & Replace Entire Ramp.**
