# Access Compliance Report

## Public Rights-of-Way

### (Curb Ramps)

| Intersection ID: 47841 | Main Street: MANITOBA_LN | Cross Street: ALVARADO_WY | Location: SE |

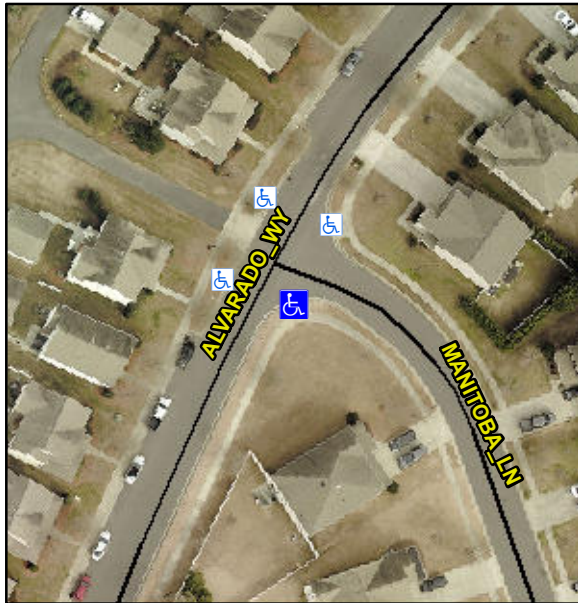
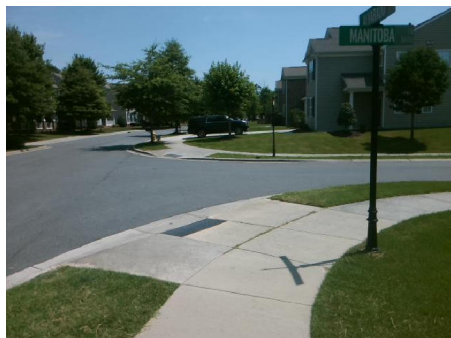
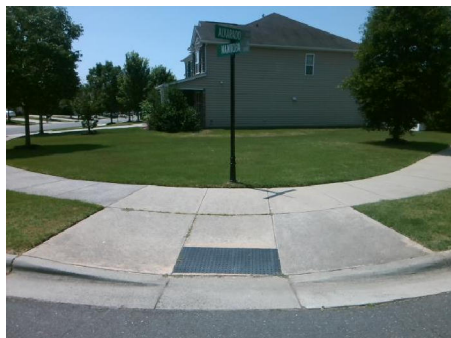
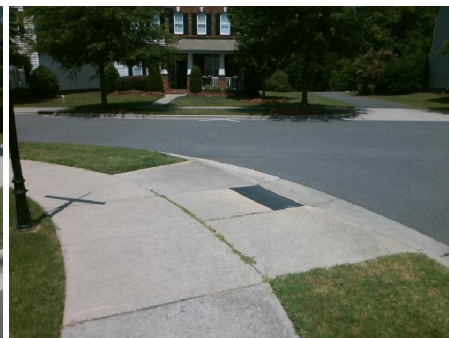
| ADA ID: 93127778A2C5 | Ramp Type: PerpDiag | Initial Pass/Fail: Fail | Overall Compliance: No |
| Severity Score: 8.75 | | | |

**R304.5.1**

| Compliance | Description | Data | Compliance | Description | Data |
|---|---|---|---|---|---|
| No | Ramp Width (in) | 46.0 | Yes | Ramp XSlope (%) | 1.6 |

**Remove & Replace Curb Ramp With Two New Directional Ramps or Equivalent.**

Total Cost: \$ **3200.00**
