Access Compliance Report Public Rights-of-Way (Curb Ramps)

Intersection ID: 9619 Main Street: PLOTT_RD Cross Street: TERRA_COTTA_DR Location: NE

ADA ID: 931538FBD184 Ramp Type: Perp Initial Pass/Fail: Fail Overall Compliance: No Severity Score: 33.75

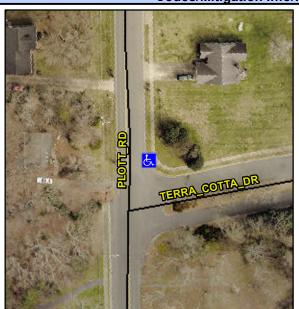
Field Measurements/Component Compliance							
Comp	iance Description	Data	Compl	iance	Description	Data	
N/A	Ramp Length (in)	50.5	No	Ramp	Slope (%)	10.4	
No	Ramp Width (in)	44.0	No	Ramp	XSlope (%)	6.8	
N/A	Flare Type LT	N/A	N/A	Flare	Type RT	N/A	
N/A	Flare Slope LT (%)	N/A	N/A	Flare	Slope RT (%)	N/A	
N/A	Flare Traversable LT?	N/A	N/A	Flare	Traversable RT?	N/A	
N/A	Landing Length (in)	N/A	N/A	DWS	Provided?	N/A	
N/A	Landing Width (in)	N/A	N/A	DWS	Contrast?	N/A	
N/A	Landing Slope (%)	N/A	N/A	DWS	Length (in)	N/A	
N/A	Landing X Slope (%)	N/A	N/A	DWS	Full Width?	N/A	
N/A	Landing Curb? (Y/N)	N/A	N/A	DWS	Offset (in)	N/A	
N/A	Shared Landing?	N/A					
N/A	Gutter Ponding?	N/A	N/A	Gutte	r Slope (%)	N/A	
N/A	Gutter Lip Ht (in)	N/A	N/A	Gutte	r X Slope (%)	N/A	
N/A	Painted X Walk1?	No	N/A	Paint	ed X Walk2?	N/A	
	X Walk 1 Direction	To W		X Wa	lk 2 Direction	N/A	
N/A	X Walk 1 Width (in)	N/A	N/A	X Wa	lk 2 Width (in)	N/A	
	X Walk 1 Slope (%)	7.4		X Wa	lk 2 Slope (%)	N/A

X Walk 1 X Slope (%)	7.3		X Wa	lk 2 X Slope (%)	N/A	
N/A	Ramp inside XWalk1?	N/A	N/A	Ramp	inside XWalk2?	N/A	
	Road Slope (%)	7.3	N/A	Clear	Space?	N/A	
	Road X Slope (%)	7.4	N/A	Clear	Space to XWalk (in)	N/A	
N/A	Any Obstructions?	N/A	N/A	Storm	n Grate/Utility Hazard?	N/A	
	Obstruction Type			Storm	n Grate/Utility Type		
		N/A				N/A	
			Yes	Surfa	ce Condition? (G/P)	Good

Possible Solutions:						
Remove & Replace Entire Ramp.						
•						
Surveyor Notes:						
N/A						
PROW/ADA:						
Not Found, R304.5.1, R304.2.2,						
R304.5.3

1850.00
