# Access Compliance Report

## Public Rights-of-Way

### (Curb Ramps)

Intersection ID: 4801	Main Street: ARKLOW_RD	Cross Street: KARYLSTURN_CT	Location: S
ADA ID: 932297F47BF8	Ramp Type: Perp	Initial Pass/Fail: Fail	Overall Compliance: No
		Severity Score: 72.5

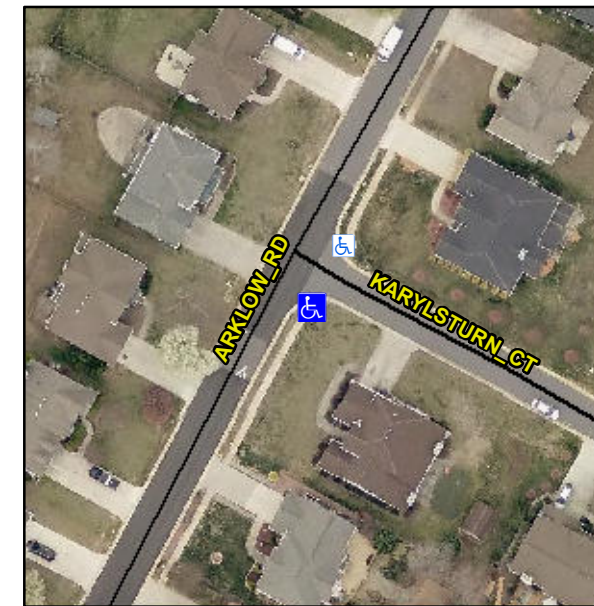
Compliance	Description	Data	Compliance	Description	Data
N/A	Ramp Length (in)	47.0	No	Ramp Slope (%)	11.1
No	Ramp Width (in)	31.0	No	Ramp XSlope (%)	7.3
N/A	Flare Type LT	N/A	N/A	Flare Type RT	N/A
N/A	Flare Slope LT (%)	N/A	N/A	Flare Slope RT (%)	N/A
N/A	Flare Traversable LT?	N/A	N/A	Flare Traversable RT?	N/A
N/A	Landing Length (in)	N/A	N/A	DWS Provided?	N/A
N/A	Landing Width (in)	N/A	N/A	DWS Contrast?	N/A
N/A	Landing Slope (%)	N/A	N/A	DWS Length (in)	N/A
N/A	Landing X Slope (%)	N/A	N/A	DWS Full Width?	N/A
N/A	Landing Curb? (Y/N)	N/A	N/A	DWS Offset (in)	N/A
N/A	Shared Landing?	N/A			
N/A	Gutter Ponding?	N/A	N/A	Gutter Slope (%)	N/A
N/A	Gutter Lip Ht (in)	N/A	N/A	Gutter X Slope (%)	N/A
N/A	Painted X Walk1?	No	N/A	Painted X Walk2?	N/A
	X Walk 1 Direction	To NE		X Walk 2 Direction	N/A
N/A	X Walk 1 Width (in)	N/A	N/A	X Walk 2 Width (in)	N/A
	X Walk 1 Slope (%)	0.2		X Walk 2 Slope (%)	N/A
	X Walk 1 X Slope (%)	9.0		X Walk 2 X Slope (%)	N/A

N/A	Ramp inside XWalk1?	N/A	N/A	Ramp inside XWalk2?	N/A
	Road Slope (%)	N/A	N/A	Clear Space?	N/A
	Road X Slope (%)	N/A	N/A	Clear Space to XWalk (in)	N/A
N/A	Any Obstructions?	N/A	N/A	Storm Grate/Utility Hazard?	N/A
	Obstruction Type			Storm Grate/Utility Type	
		N/A			N/A
			Yes	Surface Condition? (G/P)	Good

**Remove & Replace Entire Ramp.**

**R304.5.1, R304.2.2, R304.5.3**

Total Cost: \$ 1850.00
