Access Compliance Report

Public Rights-of-Way

(Curb Ramps)

Intersection ID: 11926	Main Street: WILKINSON_BV	Cross Street: BOYER_ST	Location: SW
ADA ID: 9322F8B824D4	Ramp Type: Perp	Initial Pass/Fail: Fail	Overall Compliance: No
		Severity Score: 10

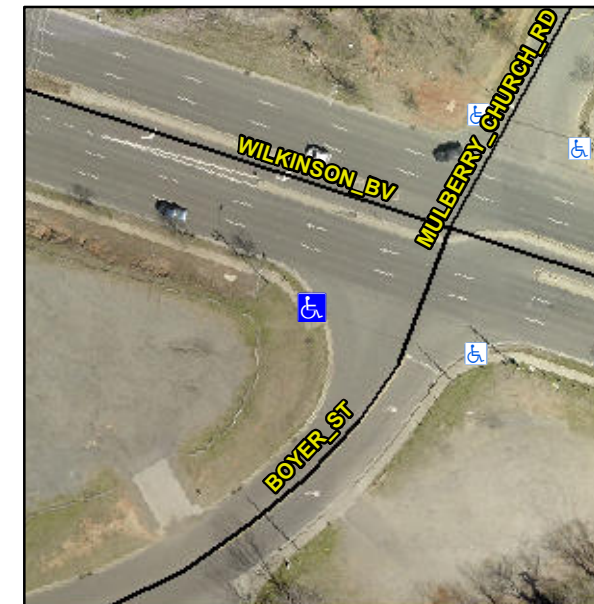
Not Found, R304.5.1, R304.5.3

Compliance	Description	Data	Compliance	Description	Data
N/A	Ramp Length (in)	108.0	Yes	Ramp Slope (%)	5.4
No	Ramp Width (in)	46.0	No	Ramp XSlope (%)	2.1
N/A	Flare Type LT	N/A	N/A	Flare Type RT	N/A
N/A	Flare Slope LT (%)	N/A	N/A	Flare Slope RT (%)	N/A
N/A	Flare Traversable LT?	N/A	N/A	Flare Traversable RT?	N/A
N/A	Landing Length (in)	N/A	N/A	DWS Provided?	N/A
N/A	Landing Width (in)	N/A	N/A	DWS Contrast?	N/A
N/A	Landing Slope (%)	N/A	N/A	DWS Length (in)	N/A
N/A	Landing X Slope (%)	N/A	N/A	DWS Full Width?	N/A
N/A	Landing Curb? (Y/N)	N/A	N/A	DWS Offset (in)	N/A
N/A	Shared Landing?	N/A			
N/A	Gutter Ponding?	N/A	N/A	Gutter Slope (%)	N/A
N/A	Gutter Lip Ht (in)	N/A	N/A	Gutter X Slope (%)	N/A
N/A	Painted X Walk1?	No	N/A	Painted X Walk2?	N/A
	X Walk 1 Direction	To SE		X Walk 2 Direction	N/A
N/A	X Walk 1 Width (in)	N/A	N/A	X Walk 2 Width (in)	N/A
	X Walk 1 Slope (%)	2.7		X Walk 2 Slope (%)	N/A
	X Walk 1 X Slope (%)	1.0		X Walk 2 X Slope (%)	N/A

N/A	Ramp inside XWalk1?	N/A	N/A	Ramp inside XWalk2?	N/A
	Road Slope (%)	N/A	N/A	Clear Space?	N/A
	Road X Slope (%)	N/A	N/A	Clear Space to XWalk (in)	N/A
N/A	Any Obstructions?	N/A	N/A	Storm Grate/Utility Hazard?	N/A
	Obstruction Type			Storm Grate/Utility Type	
		N/A			N/A
		Yes		Surface Condition? (G/P)	Good

Remove & Replace Entire Ramp.
