# Access Compliance Report

## Public Rights-of-Way

### (Curb Ramps)

Intersection ID: 44243	Main Street: KIEV_DR	Cross Street: VALERIE_DR	Location: NW
ADA ID: 9331749A8401	Ramp Type: PerpDiag	Initial Pass/Fail: Fail	Overall Compliance: No
Severity Score: 17.5			
Codes/Mitigation Info/Possible Solution		Field Measurements/Component Compliance

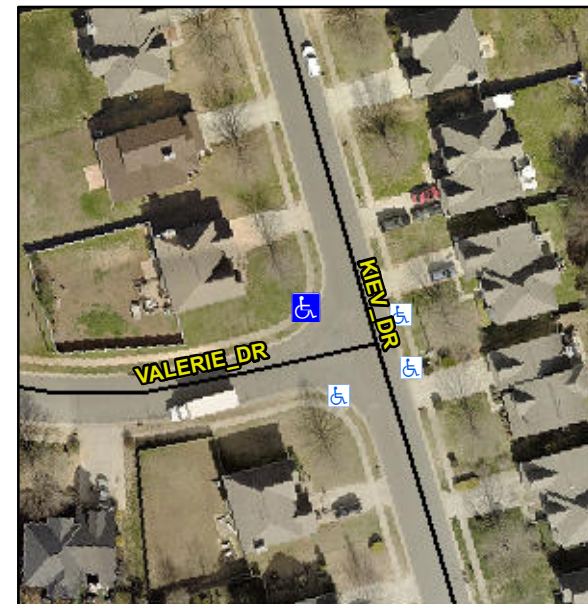
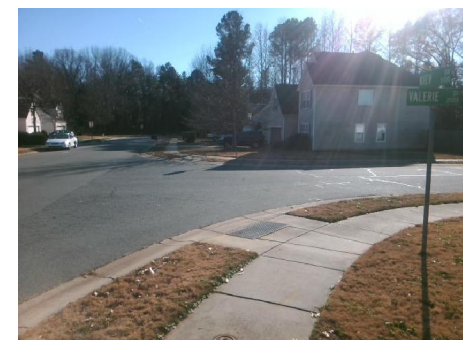
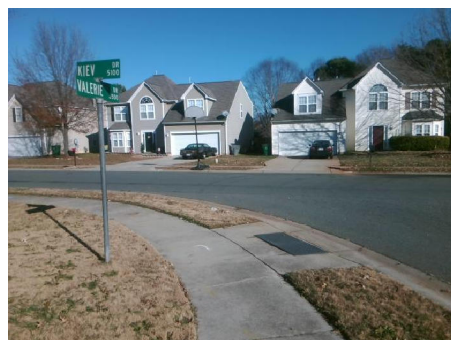
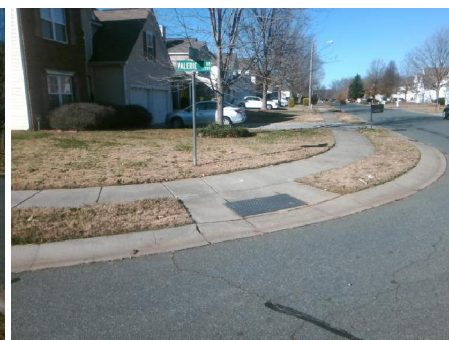
Compliance	Description	Data	Compliance	Description	Data
N/A	Ramp Length (in)	47.5	Yes	Ramp Slope (%)	6.6
No	Ramp Width (in)	35.0	Yes	Ramp XSlope (%)	1.2
N/A	Flare Type LT	N/A	N/A	Flare Type RT	N/A
N/A	Flare Slope LT (%)	N/A	N/A	Flare Slope RT (%)	N/A
N/A	Flare Traversable LT?	N/A	N/A	Flare Traversable RT?	N/A
N/A	Landing Length (in)	N/A	N/A	DWS Provided?	N/A
N/A	Landing Width (in)	N/A	N/A	DWS Contrast?	N/A
N/A	Landing Slope (%)	N/A	N/A	DWS Length (in)	N/A
N/A	Landing X Slope (%)	N/A	N/A	DWS Full Width?	N/A
N/A	Landing Curb? (Y/N)	N/A	N/A	DWS Offset (in)	N/A
N/A	Shared Landing?	N/A			
N/A	Gutter Ponding?	N/A	N/A	Gutter Slope (%)	N/A
N/A	Gutter Lip Ht (in)	N/A	N/A	Gutter X Slope (%)	N/A
N/A	Painted X Walk1?	No	N/A	Painted X Walk2?	No
	X Walk 1 Direction	To S		X Walk 2 Direction	To E
N/A	X Walk 1 Width (in)	N/A	N/A	X Walk 2 Width (in)	N/A
	X Walk 1 Slope (%)	1.1		X Walk 2 Slope (%)	1.6
	X Walk 1 X Slope (%)	0.8		X Walk 2 X Slope (%)	1.4

N/A	Ramp inside XWalk1?	N/A	N/A	Ramp inside XWalk2?	N/A
	Road Slope (%)	2.0	N/A	Clear Space?	N/A
	Road X Slope (%)	0.3	N/A	Clear Space to XWalk (in)	N/A
N/A	Any Obstructions?	N/A	N/A	Storm Grate/Utility Hazard?	N/A
	Obstruction Type			Storm Grate/Utility Type	
		N/A			N/A
			Yes	Surface Condition? (G/P)	Good

Possible Solutions:

**Remove & Replace Curb Ramp With Two New Directional Ramps or Equivalent.**
