Access Compliance Report

Public Rights-of-Way

(Curb Ramps)

Intersection ID: 52336	Main Street: WOODWARD_AV	Cross Street: KOHLER_AV	Location:	E
ADA ID: 934345E46032	Ramp Type: Perp	Initial Pass/Fail: Pass	Overall Compliance: No	Severity Score: 0
Codes/Mitigation Info/Possible Solution		Field Measurements/Component Compliance

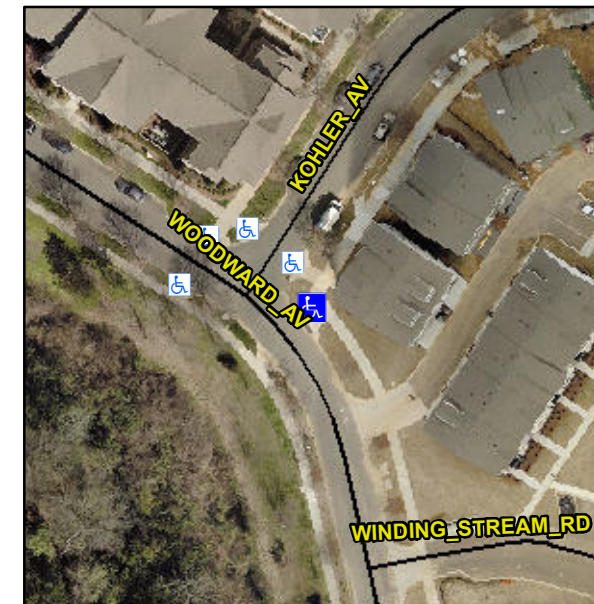
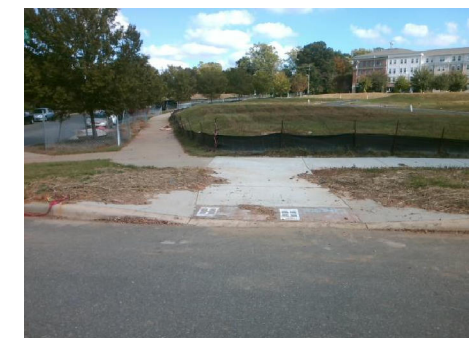
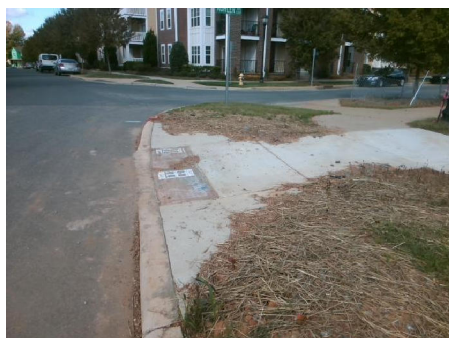
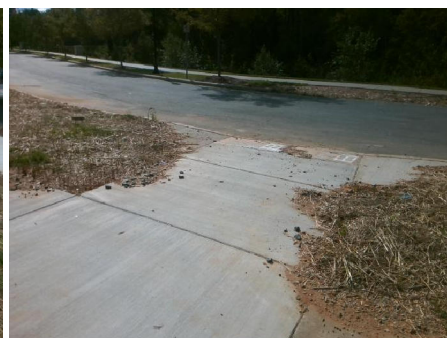
Not Found, R304.2.2-Perp, R304.3.2-Para, R302.7

Compliance	Description	Data	Compliance	Description	Data
N/A	Ramp Length (in)	70.0	Yes	Ramp Slope (%)	5.9
Yes	Ramp Width (in)	95.0	Yes	Ramp XSlope (%)	0.3
N/A	Flare Type LT	Sloped	N/A	Flare Type RT	N/A
N/A	Flare Slope LT (%)	11.2	N/A	Flare Slope RT (%)	6.0
N/A	Flare Traversable LT?	No	N/A	Flare Traversable RT?	No
Yes	Landing Length (in)	65.0	Yes	DWS Provided?	Yes
Yes	Landing Width (in)	95.0	Yes	DWS Contrast?	Yes
No	Landing Slope (%)	2.4	Yes	DWS Length (in)	24.0
Yes	Landing X Slope (%)	0.3	Yes	DWS Full Width?	Yes
N/A	Landing Curb? (Y/N)	No	Yes	DWS Offset (in)	0.0
N/A	Shared Landing?	No			
No	Gutter Ponding?	Yes	Yes	Gutter Slope (%)	0.3
Yes	Gutter Lip Ht (in)	0.0	Yes	Gutter X Slope (%)	0.5
N/A	Painted X Walk1?	No	N/A	Painted X Walk2?	N/A
	X Walk 1 Direction	To W		X Walk 2 Direction	N/A
N/A	X Walk 1 Width (in)	N/A	N/A	X Walk 2 Width (in)	N/A
	X Walk 1 Slope (%)	0.8		X Walk 2 Slope (%)	N/A
	X Walk 1 X Slope (%)	0.8		X Walk 2 X Slope (%)	N/A

N/A	Ramp inside XWalk1?	N/A	N/A	Ramp inside XWalk2?	N/A
	Road Slope (%)	N/A	N/A	Clear Space?	Yes
	Road X Slope (%)	N/A	N/A	Clear Space to XWalk (in)	N/A
Yes	Any Obstructions?	No	Yes	Storm Grate/Utility Hazard?	No
	Obstruction Type			Storm Grate/Utility Type	
		N/A			N/A
			Yes	Surface Condition? (G/P)	Good

Possible Solutions:

Remove & Replace Entire Ramp.
