Access Compliance Report

Public Rights-of-Way

(Curb Ramps)

Intersection ID: 24531	Main Street: CARMEL_RD	Cross Street: WINDWOOD_CR	Location: SW
ADA ID: 93472EF7B376	Ramp Type: PerpDiag	Initial Pass/Fail: Fail	Overall Compliance: No
			Severity Score: 21.25

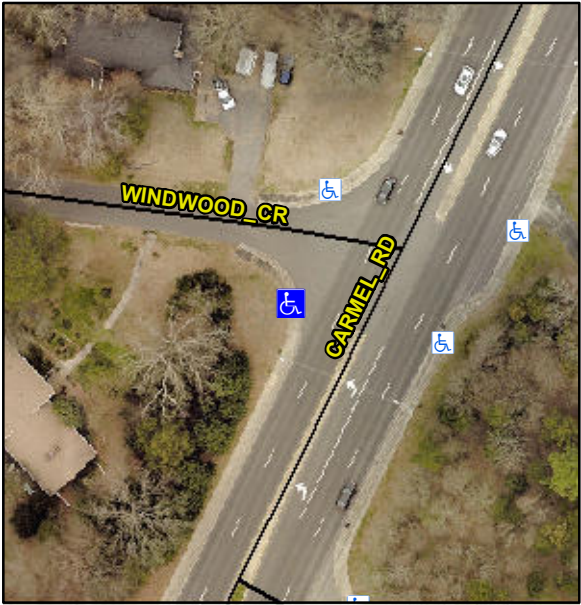
Possible Solutions:		Compliance	Description	Data	
	Remove & Replace Curb Ramp With Two New Directional Ramps or Equivalent.		N/A	Ramp Length (in)	64.0	No
			No	Ramp Width (in)	40.0	Yes
			N/A	Flare Type LT	N/A	N/A
			N/A	Flare Slope LT (%)	N/A	N/A
			N/A	Flare Traversable LT?	N/A	N/A
			N/A	Landing Length (in)	N/A	N/A
			N/A	Landing Width (in)	N/A	N/A
			N/A	Landing Slope (%)	N/A	N/A
			N/A	Landing X Slope (%)	N/A	N/A
<p>Surveyor Notes:</p> <p>N/A</p> <p>PROW/ADA:</p> <p>Not Found, R304.5.1, R304.2.2</p>			N/A	Flare Type RT	N/A	N/A
			N/A	Flare Slope RT (%)	N/A	N/A
			N/A	Flare Traversable RT?	N/A	N/A
			N/A	DWS Provided?	N/A	N/A
			N/A	DWS Contrast?	N/A	N/A
			N/A	DWS Length (in)	N/A	N/A
			N/A	DWS Full Width?	N/A	N/A
			N/A	DWS Offset (in)	N/A	N/A
			N/A	Shared Landing?	N/A	
			N/A	Gutter Ponding?	N/A	N/A
			N/A	Gutter Lip Ht (in)	N/A	N/A

N/A	Painted X Walk1?	No	N/A
				X Walk 1 Direction	To SE	X Walk 2 Direction
			N/A	X Walk 1 Width (in)	N/A	N/A
				X Walk 1 Slope (%)	3.6	X Walk 2 Slope (%)
				X Walk 1 X Slope (%)	4.0	X Walk 2 X Slope (%)
			N/A	Ramp inside XWalk1?	N/A	N/A
				Road Slope (%)	3.2	N/A
				Road X Slope (%)	3.1	N/A
			N/A	Any Obstructions?	N/A	N/A
				Obstruction Type		
					N/A	N/A
					Yes	Surface Condition? (G/P)
Total Cost:		\$ 3200.00				Good
