## **Access Compliance Report Public Rights-of-Way** (Curb Ramps)

Intersection ID: 9031 Main Street: GRANT ST **Cross Street: LAKEWOOD AV** Location: NW Initial Pass/Fail: Fail **Overall Compliance: No Severity Score:** 10 ADA ID: 934BA79713A1 Ramp Type: Perp

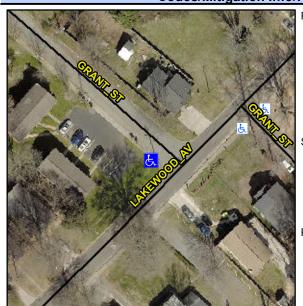
**LAKEWOOD AV** Street 1 Name Stop Condition-Street 2 None N/A Street 2 Name Stop Condition-Street 1 N/A Possible Solutions: Compliance Description N/A Remove & Replace Entire Ramp. No N/A N/A N/A N/A Surveyor Notes: N/A N/A N/A N/A N/A N/A PROW/ADA: R304.5.1
