Access Compliance Report

Public Rights-of-Way

(Curb Ramps)

Intersection ID: 16581	Main Street: MEADOWDALE_LN	Cross Street: DAWNWOOD_DR	Location: NE
ADA ID: 93559941BF4F	Ramp Type: PerpDiag	Initial Pass/Fail: Fail	Overall Compliance: No
		Severity Score: 22.5

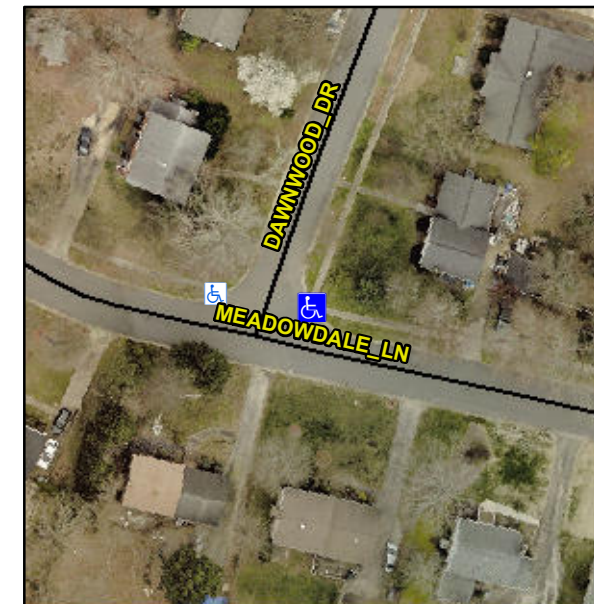
Not Found, R304.5.1, R304.2.2, R304.5.3

Compliance	Description	Data	Compliance	Description	Data
N/A	Ramp Length (in)	56.0	No	Ramp Slope (%)	8.7
No	Ramp Width (in)	37.0	No	Ramp XSlope (%)	4.7
N/A	Flare Type LT	N/A	N/A	Flare Type RT	N/A
N/A	Flare Slope LT (%)	N/A	N/A	Flare Slope RT (%)	N/A
N/A	Flare Traversable LT?	N/A	N/A	Flare Traversable RT?	N/A
N/A	Landing Length (in)	N/A	N/A	DWS Provided?	N/A
N/A	Landing Width (in)	N/A	N/A	DWS Contrast?	N/A
N/A	Landing Slope (%)	N/A	N/A	DWS Length (in)	N/A
N/A	Landing X Slope (%)	N/A	N/A	DWS Full Width?	N/A
N/A	Landing Curb? (Y/N)	N/A	N/A	DWS Offset (in)	N/A
N/A	Shared Landing?	N/A			
N/A	Gutter Ponding?	N/A	N/A	Gutter Slope (%)	N/A
N/A	Gutter Lip Ht (in)	N/A	N/A	Gutter X Slope (%)	N/A
N/A	Painted X Walk1?	No	N/A	Painted X Walk2?	No
	X Walk 1 Direction	To NW		X Walk 2 Direction	To SW
N/A	X Walk 1 Width (in)	N/A	N/A	X Walk 2 Width (in)	N/A
	X Walk 1 Slope (%)	4.7		X Walk 2 Slope (%)	0.9
	X Walk 1 X Slope (%)	4.8		X Walk 2 X Slope (%)	4.4

Remove & Replace Curb Ramp With Two New Directional Ramps or Equivalent.
