Access Compliance Report Public Rights-of-Way (Curb Ramps)

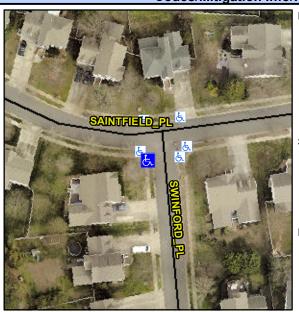
Intersection ID: 24484 Main Street: SAINTFIELD_PL Cross Street: SWINFORD_PL Location: SW

Street 1 Name	SWINFORD PL
Stop Condition-Street 2	StopSign
Street 2 Name	N/A
Stop Condition-Street 1	N/A
