# Access Compliance Report

## Public Rights-of-Way

### (Curb Ramps)

| Intersection ID: 13809 | Main Street: CHESTERFIELD_AV | Cross Street: ST_JULIEN_ST | Location: W |

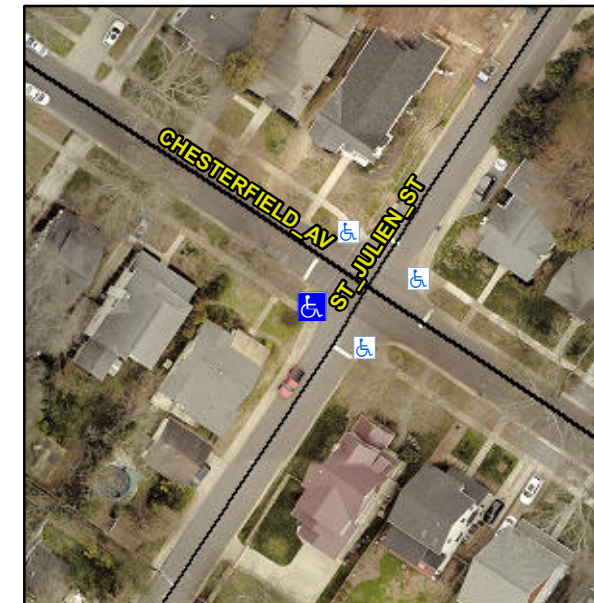
#### Field Measurements/Component Compliance

| ADA ID: 9362C8B1D37E | Ramp Type: BlendTrans1 | Initial Pass/Fail: Pass | Overall Compliance: No |
| | | Severity Score: 2.5 | |

**Not Found, R304.2.1, R305.1.4, R305.2, R302.7**

| Compliance | Description | Data | Compliance | Description | Data |
|---|---|---|---|---|---|
| No | Landing Width (in) | 42.0 | Yes | DWS Contrast? | Yes |
| Yes | Landing X Slope (%) | 0.2 | No | DWS Full Width? | No |
| N/A | Landing Curb? (Y/N) | No | No | DWS Offset (in) | 5.0 |
| No | Gutter Ponding? | Yes | Yes | Gutter Slope (%) | 1.7 |

**Remove & Replace Curb Ramp With Two New Directional Ramps or Equivalent.**

Total Cost: \$ 3200.00

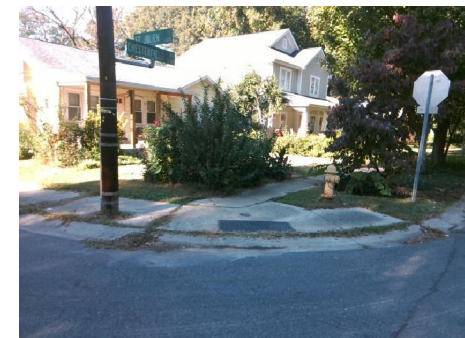
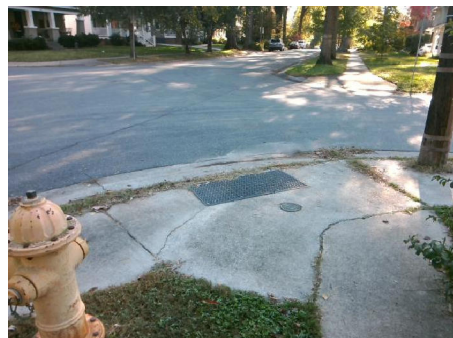
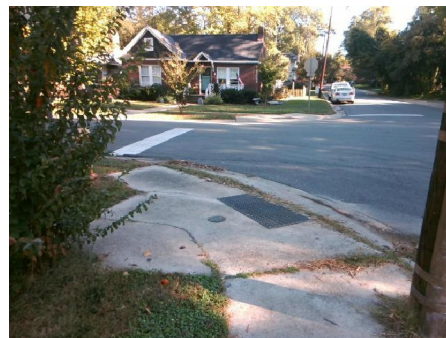
Street 1 Name ST JULIEN ST  
 Stop Condition-Street 1 StopSign  
 Street 2 Name CHESTERFIELD AV  
 Stop Condition-Street 2 StopSign
