Intersection ID: 10194	Main Street: BURTON_ST	Cross Street: SPRING_ST	Location:	S
ADA ID: 9363C0AA8B26	Ramp Type: Perp	Initial Pass/Fail: Fail	Overall Compliance: No	Severity Score: 12.5

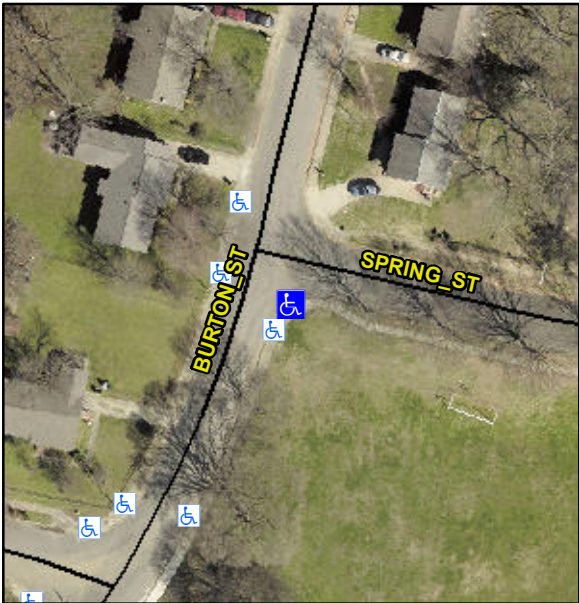
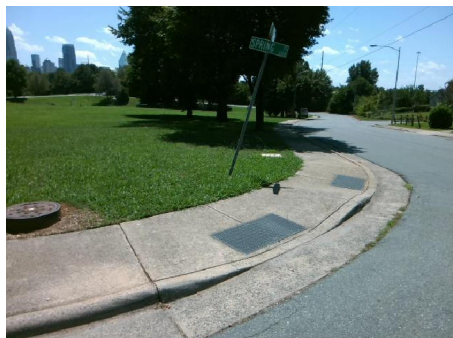
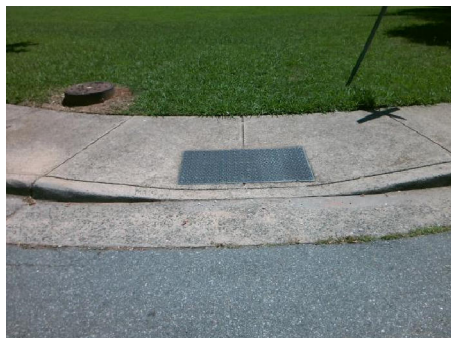
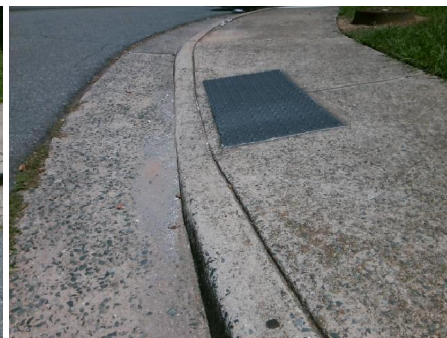
Possible Solutions:		<b>Compliance</b>	<b>Description</b>	<b>Data</b>	<b>Compliance</b>	<b>Description</b>	<b>Data</b>
	<b>Remove &amp; Replace Entire Ramp.</b>		<b>N/A</b>	Ramp Length (in)	<b>60.5</b>	<b>No</b>	Ramp Slope (%)	<b>8.4</b>
			<b>Yes</b>	Ramp Width (in)	<b>51.0</b>	<b>Yes</b>	Ramp XSlope (%)	<b>1.1</b>
			<b>N/A</b>	Flare Type LT	<b>N/A</b>	<b>N/A</b>	Flare Type RT	<b>N/A</b>
			<b>N/A</b>	Flare Slope LT (%)	<b>N/A</b>	<b>N/A</b>	Flare Slope RT (%)	<b>N/A</b>
			<b>N/A</b>	Flare Traversable LT?	<b>N/A</b>	<b>N/A</b>	Flare Traversable RT?	<b>N/A</b>
			<b>N/A</b>	Landing Length (in)	<b>N/A</b>	<b>N/A</b>	DWS Provided?	<b>N/A</b>
			<b>N/A</b>	Landing Width (in)	<b>N/A</b>	<b>N/A</b>	DWS Contrast?	<b>N/A</b>
			<b>N/A</b>	Landing Slope (%)	<b>N/A</b>	<b>N/A</b>	DWS Length (in)	<b>N/A</b>
			<b>N/A</b>	Landing X Slope (%)	<b>N/A</b>	<b>N/A</b>	DWS Full Width?	<b>N/A</b>

Surveyor Notes:		<b>N/A</b>	<b>N/A</b>	Landing Curb? (Y/N)	<b>N/A</b>	<b>N/A</b>	DWS Offset (in)	<b>N/A</b>
PROW/ADA:		<b>Not Found, R304.2.2</b>	<b>N/A</b>	Shared Landing?	<b>N/A</b>			
			<b>N/A</b>	Gutter Ponding?	<b>N/A</b>	<b>N/A</b>	Gutter Slope (%)	<b>N/A</b>
			<b>N/A</b>	Gutter Lip Ht (in)	<b>1.0</b>	<b>N/A</b>	Gutter X Slope (%)	<b>N/A</b>
			<b>N/A</b>	Painted X Walk1?	<b>No</b>	<b>N/A</b>	Painted X Walk2?	<b>N/A</b>
				X Walk 1 Direction	<b>To NE</b>		X Walk 2 Direction	<b>N/A</b>
			<b>N/A</b>	X Walk 1 Width (in)	<b>N/A</b>	<b>N/A</b>	X Walk 2 Width (in)	<b>N/A</b>
				X Walk 1 Slope (%)	<b>5.3</b>		X Walk 2 Slope (%)	<b>N/A</b>
				X Walk 1 X Slope (%)	<b>1.8</b>		X Walk 2 X Slope (%)	<b>N/A</b>
			<b>N/A</b>	Ramp inside XWalk1?	<b>N/A</b>	<b>N/A</b>	Ramp inside XWalk2?	<b>N/A</b>
				Road Slope (%)	<b>N/A</b>	<b>N/A</b>	Clear Space?	<b>N/A</b>
				Road X Slope (%)	<b>N/A</b>	<b>N/A</b>	Clear Space to XWalk (in)	<b>N/A</b>

<b>N/A</b>	Any Obstructions?	<b>N/A</b>	<b>N/A</b>	Storm Grate/Utility Hazard?	<b>N/A</b>
				Obstruction Type			Storm Grate/Utility Type	
					<b>N/A</b>			<b>N/A</b>
						<b>Yes</b>	Surface Condition? (G/P)	<b>Good</b>
Street 1 Name		<b>SPRING ST</b>						
Stop Condition-Street 2		<b>StopSign</b>						
Street 2 Name		<b>N/A</b>						
Stop Condition-Street 1		<b>N/A</b>						
Total Cost:		<b>\$ 1850.00</b>
