# Access Compliance Report

## Public Rights-of-Way

### (Curb Ramps)

| Intersection ID: 18204 | Main Street: IDLEWILD_RD | Cross Street: OAK_DR | Location: W |

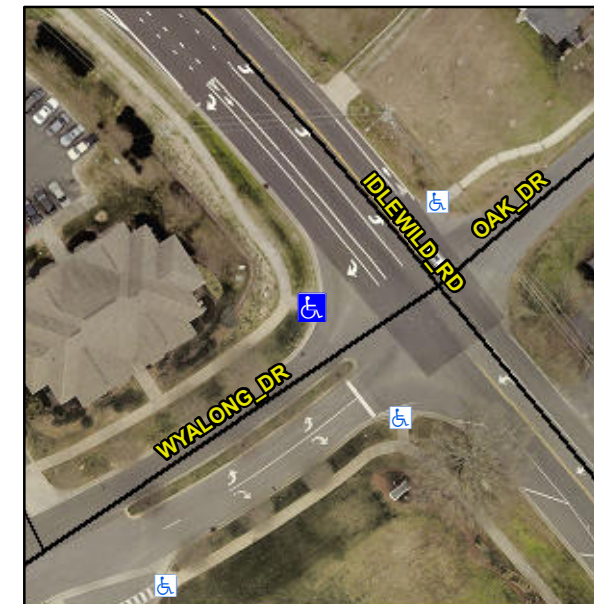
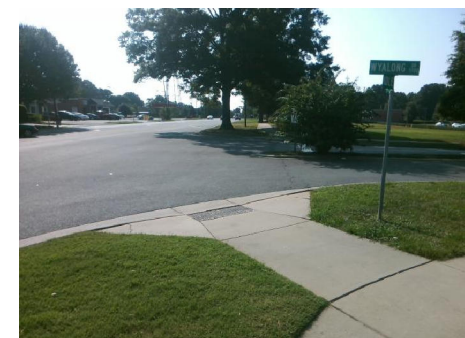
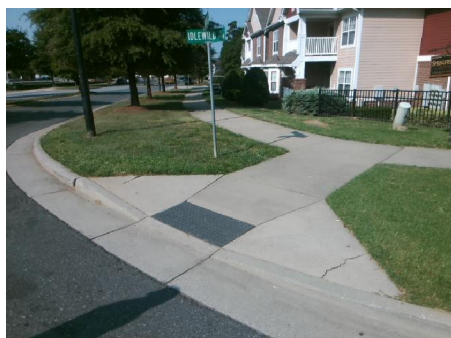
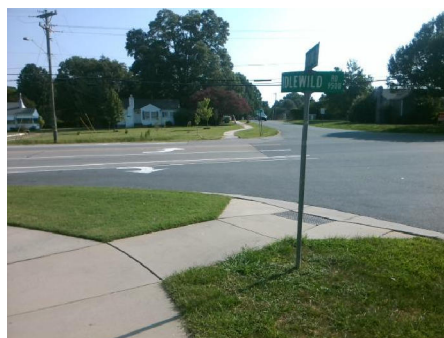
| ADA ID: 9369683E59CE | Ramp Type: BlendTrans1 | Initial Pass/Fail: Pass | Overall Compliance: No |

| Severity Score: 0.25 | | | |

**Not Found, R304.5.3**

| Compliance | Description | Data | Compliance | Description | Data |
|---|---|---|---|---|---|
| Yes | Ramp Width (in) | 48.0 | No | BlendTrans XSlope (%) | 2.2 |
| | | | No | Curb Slope (%) | 13.5 |

**Remove & Replace Curb Ramp With Two New Directional Ramps or Equivalent.**

Total Cost: \$ 3200.00
