# Access Compliance Report

## Public Rights-of-Way

### (Curb Ramps)

Intersection ID: 14914	Main Street: COOK_ST	Cross Street: CRESCENT_AV	Location: S
ADA ID: 936BB73DFD44	Ramp Type: Perp	Initial Pass/Fail: Fail	Overall Compliance: No
Severity Score: 37.5			
Codes/Mitigation Info/Possible Solution		Field Measurements/Component Compliance

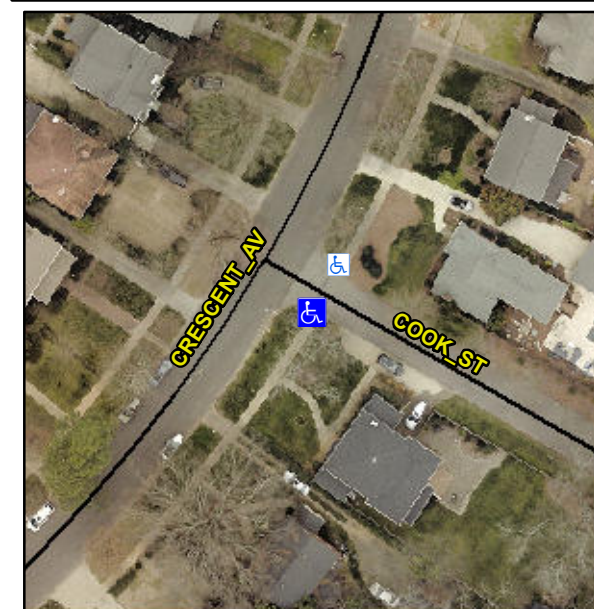
Compliance	Description	Data	Compliance	Description	Data
N/A	Ramp Length (in)	91.0	No	Ramp Slope (%)	10.6
Yes	Ramp Width (in)	59.0	No	Ramp XSlope (%)	7.3
N/A	Flare Type LT	N/A	N/A	Flare Type RT	N/A
N/A	Flare Slope LT (%)	N/A	N/A	Flare Slope RT (%)	N/A
N/A	Flare Traversable LT?	N/A	N/A	Flare Traversable RT?	N/A
N/A	Landing Length (in)	N/A	N/A	DWS Provided?	N/A
N/A	Landing Width (in)	N/A	N/A	DWS Contrast?	N/A
N/A	Landing Slope (%)	N/A	N/A	DWS Length (in)	N/A
N/A	Landing X Slope (%)	N/A	N/A	DWS Full Width?	N/A
N/A	Landing Curb? (Y/N)	N/A	N/A	DWS Offset (in)	N/A
N/A	Shared Landing?	N/A			
N/A	Gutter Ponding?	N/A	N/A	Gutter Slope (%)	N/A
N/A	Gutter Lip Ht (in)	N/A	N/A	Gutter X Slope (%)	N/A
N/A	Painted X Walk1?	No	N/A	Painted X Walk2?	N/A
	X Walk 1 Direction	To NE		X Walk 2 Direction	N/A
N/A	X Walk 1 Width (in)	N/A	N/A	X Walk 2 Width (in)	N/A
	X Walk 1 Slope (%)	3.8		X Walk 2 Slope (%)	N/A
	X Walk 1 X Slope (%)	2.6		X Walk 2 X Slope (%)	N/A

N/A	Ramp inside XWalk1?	N/A	N/A	Ramp inside XWalk2?	N/A
	Road Slope (%)	N/A	N/A	Clear Space?	N/A
	Road X Slope (%)	N/A	N/A	Clear Space to XWalk (in)	N/A
N/A	Any Obstructions?	N/A	N/A	Storm Grate/Utility Hazard?	N/A
	Obstruction Type			Storm Grate/Utility Type	
		N/A			N/A
			Yes	Surface Condition? (G/P)	Good

Possible Solutions:

**Remove & Replace Entire Ramp.**

**R304.2.2, R304.5.3**

Total Cost: \$ 1850.00
