# Access Compliance Report

## Public Rights-of-Way

### (Curb Ramps)

Intersection ID: N/A	Main Street: YORKMONT_RD	Cross Street: OAK_LAKE_BV	Location: SW
ADA ID: 936E7BF5F156	Ramp Type: PerpDiag	Initial Pass/Fail: Fail	Overall Compliance: No
		Severity Score: 25

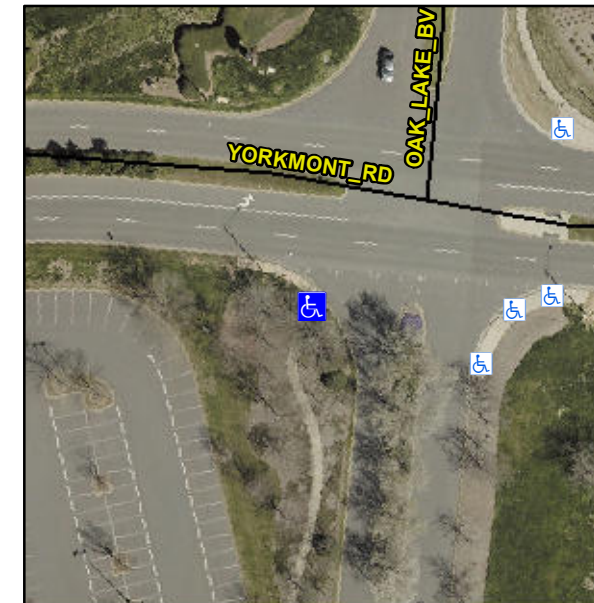
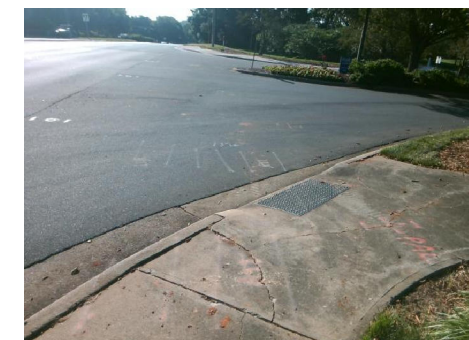
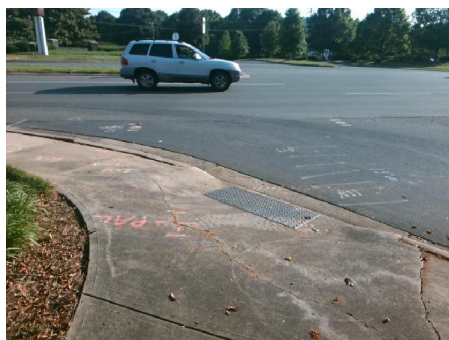
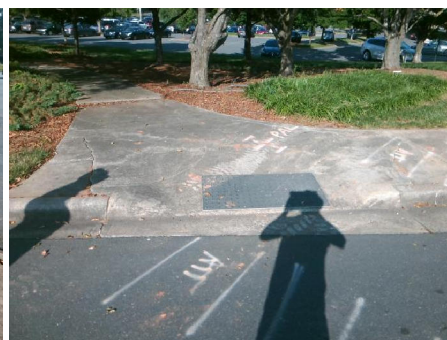
**Not Found, R304.2.2, R304.5.3**

Compliance	Description	Data	Compliance	Description	Data
N/A	Ramp Length (in)	83.0	No	Ramp Slope (%)	9.0
Yes	Ramp Width (in)	68.0	No	Ramp XSlope (%)	5.6
N/A	Flare Type LT	N/A	N/A	Flare Type RT	N/A
N/A	Flare Slope LT (%)	N/A	N/A	Flare Slope RT (%)	N/A
N/A	Flare Traversable LT?	N/A	N/A	Flare Traversable RT?	N/A
N/A	Landing Length (in)	N/A	N/A	DWS Provided?	N/A
N/A	Landing Width (in)	N/A	N/A	DWS Contrast?	N/A
N/A	Landing Slope (%)	N/A	N/A	DWS Length (in)	N/A
N/A	Landing X Slope (%)	N/A	N/A	DWS Full Width?	N/A
N/A	Landing Curb? (Y/N)	N/A	N/A	DWS Offset (in)	N/A
N/A	Shared Landing?	N/A			
N/A	Gutter Ponding?	N/A	N/A	Gutter Slope (%)	N/A
N/A	Gutter Lip Ht (in)	N/A	N/A	Gutter X Slope (%)	N/A
N/A	Painted X Walk1?	No	N/A	Painted X Walk2?	No
	X Walk 1 Direction	To E		X Walk 2 Direction	To N
N/A	X Walk 1 Width (in)	N/A	N/A	X Walk 2 Width (in)	N/A
	X Walk 1 Slope (%)	1.9		X Walk 2 Slope (%)	6.8
	X Walk 1 X Slope (%)	8.1		X Walk 2 X Slope (%)	0.3

N/A	Ramp inside XWalk1?	N/A	N/A	Ramp inside XWalk2?	N/A
	Road Slope (%)	5.6	N/A	Clear Space?	N/A
	Road X Slope (%)	5.8	N/A	Clear Space to XWalk (in)	N/A
N/A	Any Obstructions?	N/A	N/A	Storm Grate/Utility Hazard?	N/A
	Obstruction Type			Storm Grate/Utility Type	
		N/A			N/A
		Yes		Surface Condition? (G/P)	Good

**Remove & Replace Curb Ramp With Two New Directional Ramps or Equivalent.**

Total Cost: \$ 3200.00
