# Access Compliance Report

## Public Rights-of-Way (Curb Ramps)

| Intersection ID: 20966 | Main Street: Kelford_LN | Cross Street: Shadowstone_DR | Location: S |
| ADA ID: 93746F49542F | Ramp Type: BlendTrans2 | Initial Pass/Fail: Fail | Overall Compliance: No |

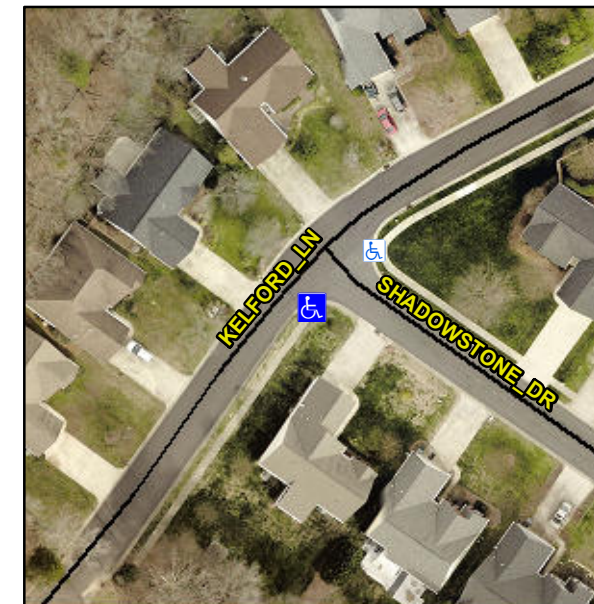
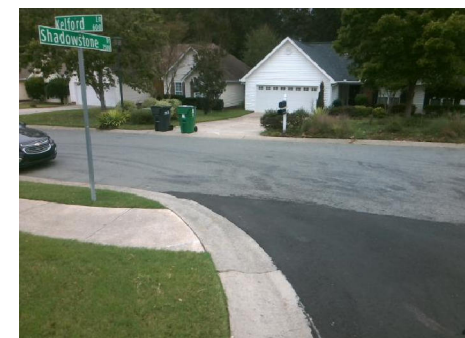
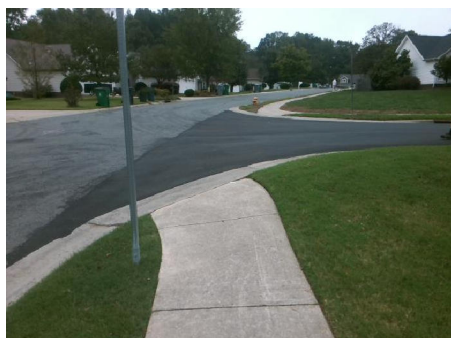
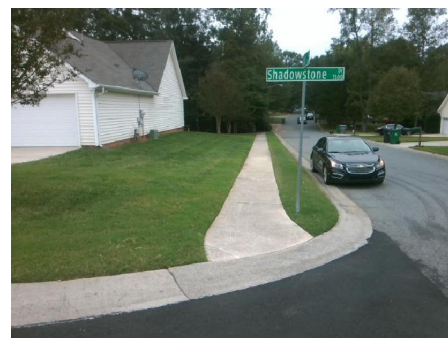
| | | Severity Score: 25 | |

**R304.5.3**

| Compliance | Description | Data | Compliance | Description | Data |
|---|---|---|---|---|---|
| Yes | Ramp Width (in) | 65.0 | No | BlendTrans XSlope (%) | 8.5 |

**Remove & Replace Curb Ramp With Two New Directional Ramps or Equivalent.**

**\$ 3200.00**
