## **Access Compliance Report Public Rights-of-Way** (Curb Ramps)

Intersection ID: 12405 Main Street: ENDOLWOOD RD Cross Street: KIMMERLY\_GLEN\_LN Location: NE **Overall Compliance: No** ADA ID: 93783010C549 Ramp Type: Perp Initial Pass/Fail: Fail Severity Score: 46.25

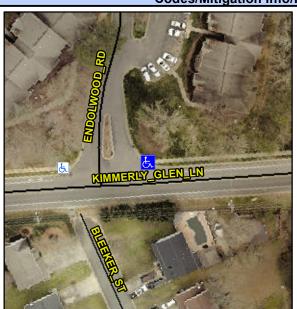
| Possible Solutions: | Co |
|---|---|
| R304.5.1, R304.2.2, R304.5.3 | N/ |

| Field Measurements/Component Compliance | | | | | | | |
|---|---|---|---|---|---|--|--|
| N/A | Ramp Length (in) | 26.0 | No | Ramp Slope (%) | 10.3 | | |
| No | Ramp Width (in) | 40.0 | No | Ramp XSlope (%) | 8.2 | | |

| Possible Solutions: | Co |
|---|---|
| Remove & Replace Entire Ramp. | N/ |
