# Access Compliance Report

## Public Rights-of-Way

### (Curb Ramps)

Intersection ID: 48943	Main Street: CALDWELL RIDGE PY	Cross Street: MORGAN LEE AV	Location: NE
ADA ID: 937F24DE936C	Ramp Type: BlendTrans1	Initial Pass/Fail: Fail	Overall Compliance: No
Severity Score: 10			
Codes/Mitigation Info/Possible Solution		Field Measurements/Component Compliance

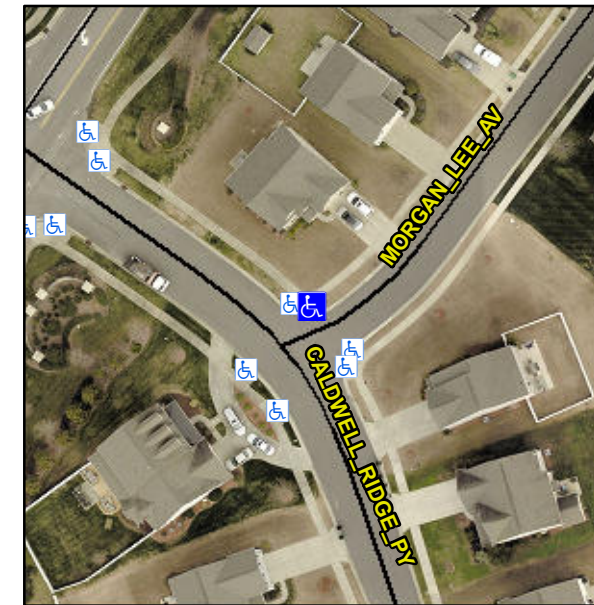
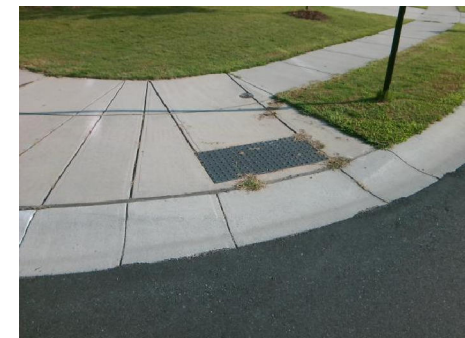
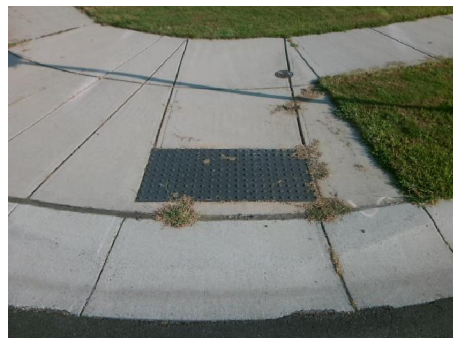
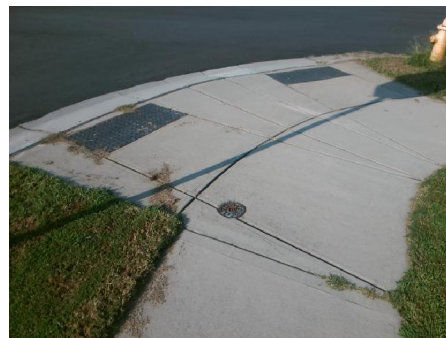
**Not Found, R304.5.1, R304.5.3**

Compliance	Description	Data	Compliance	Description	Data
N/A	Ramp Length (in)	71.0	Yes	BlendTrans Slope (%)	2.2
No	Ramp Width (in)	47.5	No	BlendTrans XSlope (%)	2.9
N/A	Flare Type LT	N/A	N/A	Flare Type RT	N/A
N/A	Flare Slope LT (%)	N/A	N/A	Flare Slope RT (%)	N/A
N/A	Flare Traversable LT?	N/A	N/A	Flare Traversable RT?	N/A
N/A	Landing Length (in)	N/A	N/A	DWS Provided?	N/A
N/A	Landing Width (in)	N/A	N/A	DWS Contrast?	N/A
N/A	Landing Slope (%)	N/A	N/A	DWS Length (in)	N/A
N/A	Landing X Slope (%)	N/A	N/A	DWS Full Width?	N/A
N/A	Landing Curb? (Y/N)	N/A	N/A	DWS Offset (in)	N/A
N/A	Shared Landing?	N/A			
N/A	Gutter Ponding?	N/A	N/A	Gutter Slope (%)	N/A
N/A	Gutter Lip Ht (in)	N/A	N/A	Gutter X Slope (%)	N/A
N/A	Painted X Walk1?	No	N/A	Painted X Walk2?	N/A
	X Walk 1 Direction	To SE		X Walk 2 Direction	N/A
	X Walk 1 Width (in)	N/A		X Walk 2 Width (in)	N/A
	X Walk 1 Slope (%)	1.7		X Walk 2 Slope (%)	N/A
	X Walk 1 X Slope (%)	1.4		X Walk 2 X Slope (%)	N/A

N/A	Ramp inside XWalk1?	N/A	N/A	Ramp inside XWalk2?	N/A
	Road Slope (%)	1.4		Clear Space?	N/A
	Road X Slope (%)	1.7	N/A	Clear Space to XWalk (in)	N/A
N/A	Any Obstructions?	N/A	N/A	Storm Grate/Utility Hazard?	N/A
	Obstruction Type			Storm Grate/Utility Type	
		N/A			N/A
			Yes	Surface Condition? (G/P)	Good
			No	Curb Slope (%)	12.5

**Remove & Replace Curb Ramp With Two New Directional Ramps or Equivalent.**
