Access Compliance Report

Public Rights-of-Way

(Curb Ramps)

Intersection ID: 53252	Main Street: MARLOWE_AV	Cross Street: FLEETWOOD_DR	Location: NE
ADA ID: 938234742766	Ramp Type: Perp	Initial Pass/Fail: Fail	Overall Compliance: No
Codes/Mitigation Info/Possible Solution		Field Measurements/Component Compliance	
Severity Score: 13.75

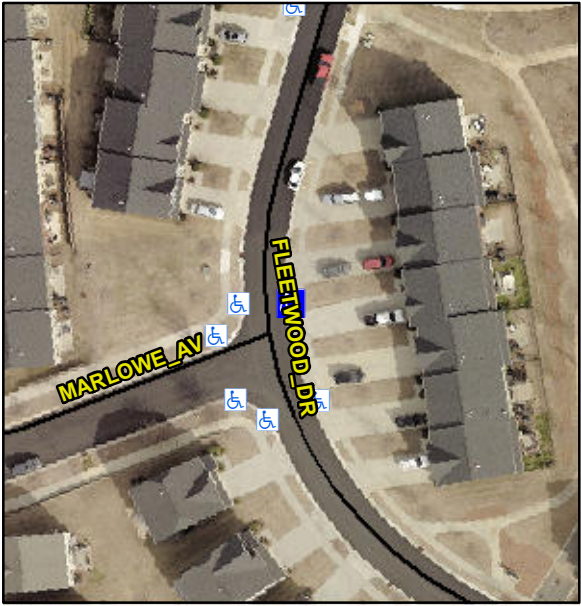
Possible Solutions:						
	Remove & Replace Entire Ramp.						
	Surveyor Notes:						
	N/A						
	PROW/ADA:						
	R304.2.2						
		Compliance	Description	Data	Compliance	Description	Data
		N/A	Ramp Length (in)	48.0	No	Ramp Slope (%)	10.2
		Yes	Ramp Width (in)	48.0	Yes	Ramp XSlope (%)	2.2
		N/A	Flare Type LT	N/A	N/A	Flare Type RT	N/A
Street 1 Name FLEETWOOD DR Stop Condition-Street 2 None Street 2 Name N/A Stop Condition-Street 1 N/A		N/A	Flare Slope LT (%)	N/A	N/A	Flare Slope RT (%)	N/A
		N/A	Flare Traversable LT?	N/A	N/A	Flare Traversable RT?	N/A
		N/A	Landing Length (in)	N/A	N/A	DWS Provided?	N/A
		N/A	Landing Width (in)	N/A	N/A	DWS Contrast?	N/A
		N/A	Landing Slope (%)	N/A	N/A	DWS Length (in)	N/A
		N/A	Landing X Slope (%)	N/A	N/A	DWS Full Width?	N/A
		N/A	Landing Curb? (Y/N)	N/A	N/A	DWS Offset (in)	N/A
		N/A	Shared Landing?	N/A			
		N/A	Gutter Ponding?	N/A	N/A	Gutter Slope (%)	N/A
		N/A	Gutter Lip Ht (in)	N/A	N/A	Gutter X Slope (%)	N/A
