Access Compliance Report

Public Rights-of-Way

(Curb Ramps)

Intersection ID: 6358	Main Street: BLACK_TRAIL_CT	Cross Street: MILHAVEN_LN	Location: SW
ADA ID: 93846CB6FBA9	Ramp Type: BlendTrans1	Initial Pass/Fail: Fail	Overall Compliance: No
Codes/Mitigation Info/Possible Solution		Field Measurements/Component Compliance	
Severity Score: 33.75

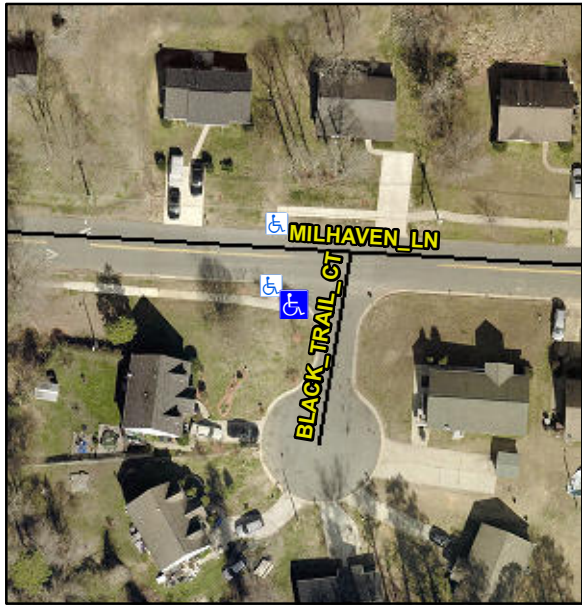
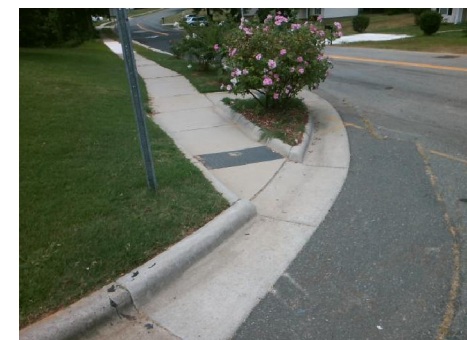
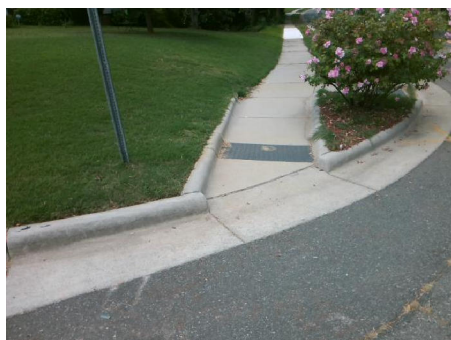
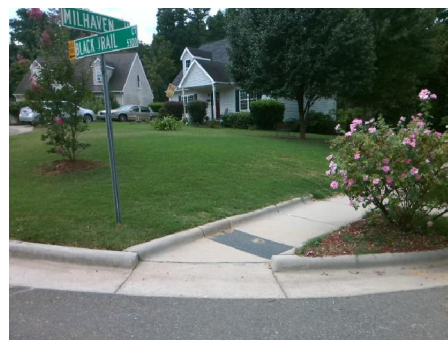
Not Found, R304.5.1, R304.5.3

Compliance	Description	Data	Compliance	Description	Data
N/A	Ramp Length (in)	84.0	Yes	BlendTrans Slope (%)	3.7
No	Ramp Width (in)	45.5	No	BlendTrans XSlope (%)	7.4
N/A	Flare Type LT	N/A	N/A	Flare Type RT	N/A
N/A	Flare Slope LT (%)	N/A	N/A	Flare Slope RT (%)	N/A
N/A	Flare Traversable LT?	N/A	N/A	Flare Traversable RT?	N/A
N/A	Landing Length (in)	N/A	N/A	DWS Provided?	N/A
N/A	Landing Width (in)	N/A	N/A	DWS Contrast?	N/A
N/A	Landing Slope (%)	N/A	N/A	DWS Length (in)	N/A
N/A	Landing X Slope (%)	N/A	N/A	DWS Full Width?	N/A
N/A	Landing Curb? (Y/N)	N/A	N/A	DWS Offset (in)	N/A
N/A	Shared Landing?	N/A			
N/A	Gutter Ponding?	N/A	N/A	Gutter Slope (%)	N/A
N/A	Gutter Lip Ht (in)	N/A	N/A	Gutter X Slope (%)	N/A
N/A	Painted X Walk1?	No	N/A	Painted X Walk2?	N/A
	X Walk 1 Direction	To E		X Walk 2 Direction	N/A
	X Walk 1 Width (in)	N/A		X Walk 2 Width (in)	N/A
	X Walk 1 Slope (%)	4.7		X Walk 2 Slope (%)	N/A
	X Walk 1 X Slope (%)	8.3		X Walk 2 X Slope (%)	N/A

N/A	Ramp inside XWalk1?	N/A	N/A	Ramp inside XWalk2?	N/A
	Road Slope (%)	8.3		Clear Space?	N/A
	Road X Slope (%)	4.7	N/A	Clear Space to XWalk (in)	N/A
N/A	Any Obstructions?	N/A	N/A	Storm Grate/Utility Hazard?	N/A
	Obstruction Type			Storm Grate/Utility Type	
		N/A			N/A
			Yes	Surface Condition? (G/P)	Good
			No	Curb Slope (%)	17.3

Remove & Replace Curb Ramp With Two New Directional Ramps or Equivalent.
