Access Compliance Report

Public Rights-of-Way

(Curb Ramps)

Intersection ID: 14004	Main Street: ELMIN_ST	Cross Street: OLD_STEELE_CREEK_RD	Location: SE
ADA ID: 9391675A6591	Ramp Type: ParaDiag	Initial Pass/Fail: Pass	Overall Compliance: No
Severity Score: 0.25			
Codes/Mitigation Info/Possible Solution		Field Measurements/Component Compliance

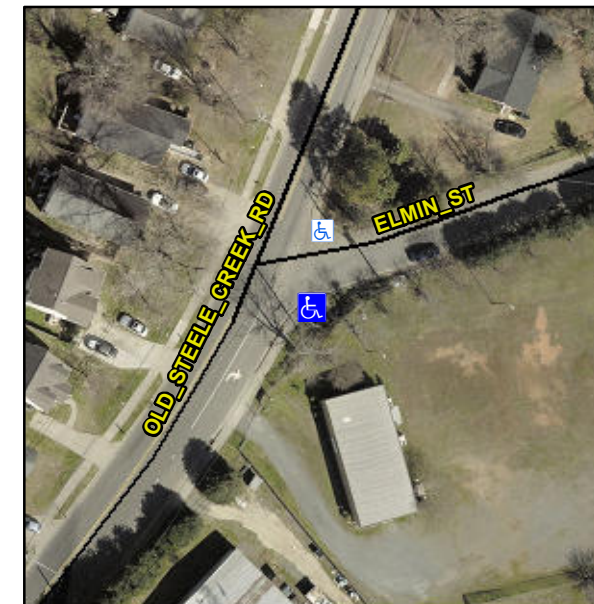
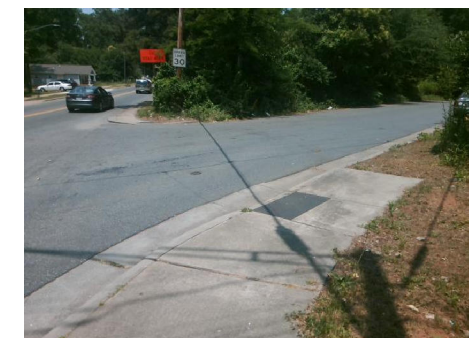
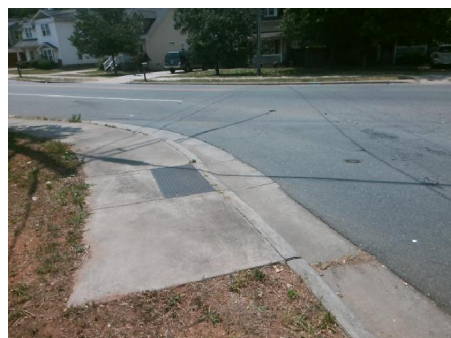
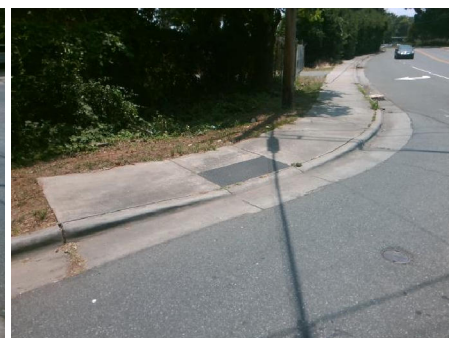
Compliance	Description	Data	Compliance	Description	Data
N/A	Ramp Length LT (in)	69.0	N/A	Ramp Length RT (in)	55.0
Yes	Ramp Width LT (in)	60.0	Yes	Ramp Width RT (in)	60.0
Yes	Ramp Slope LT (%)	5.3	Yes	Ramp Slope RT (%)	5.9
Yes	Ramp XSlope LT (%)	1.4	No	Ramp XSlope RT (%)	3.3
Yes	Landing Length (in)	60.0	Yes	DWS Provided?	Yes
Yes	Landing Width (in)	48.5	Yes	DWS Contrast?	Yes
Yes	Landing Slope (%)	1.2	Yes	DWS Length (in)	24.5
Yes	Landing X Slope (%)	0.2	Yes	DWS Full Width?	Yes
N/A	Landing Curb? (Y/N)	No	Yes	DWS Offset (in)	1.5
N/A	Shared Landing?	No			
Yes	Gutter Ponding?	No	Yes	Gutter Slope (%)	3.4
Yes	Gutter Lip Ht (in)	0.0	Yes	Gutter X Slope (%)	0.1
N/A	Painted X Walk1?	No	N/A	Painted X Walk2?	No
	X Walk 1 Direction	To N		X Walk 2 Direction	To W
N/A	X Walk 1 Width (in)	N/A	N/A	X Walk 2 Width (in)	N/A
	X Walk 1 Slope (%)	1.8		X Walk 2 Slope (%)	0.7
	X Walk 1 X Slope (%)	0.9		X Walk 2 X Slope (%)	1.4
N/A	Ramp inside XWalk1?	N/A	N/A	Ramp inside XWalk2?	N/A

Road Slope (%)	0.1	N/A	Clear Space?	Yes
	Road X Slope (%)	2.9	N/A	Clear Space to XWalk (in)	N/A
Yes	Any Obstructions?	No	Yes	Storm Grate/Utility Hazard?	No
	Obstruction Type			Storm Grate/Utility Type	
		N/A			N/A
			Yes	Surface Condition? (G/P)	Good
			N/A	Curb Slope (%)	25.6

Possible Solutions:

Remove & Replace Curb Ramp With Two New Directional Ramps or Equivalent.

R304.5.3
