# Access Compliance Report

## Public Rights-of-Way

### (Curb Ramps)

Intersection ID: 8969	Main Street: BEATTIES_FORD_RD	Cross Street: CELIA_AV	Location: SW
ADA ID: 939CE3CD808B	Ramp Type: Perp	Initial Pass/Fail: Fail	Overall Compliance: No
Severity Score: 10			
Codes/Mitigation Info/Possible Solution		Field Measurements/Component Compliance

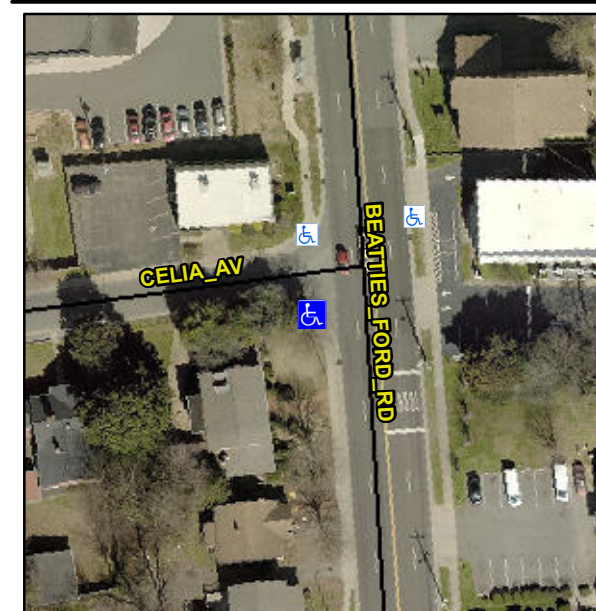
**Not Found, R304.5.1, R304.5.3**

Compliance	Description	Data	Compliance	Description	Data
N/A	Ramp Length (in)	72.0	Yes	Ramp Slope (%)	5.1
No	Ramp Width (in)	37.0	No	Ramp XSlope (%)	4.5
N/A	Flare Type LT	N/A	N/A	Flare Type RT	N/A
N/A	Flare Slope LT (%)	N/A	N/A	Flare Slope RT (%)	N/A
N/A	Flare Traversable LT?	N/A	N/A	Flare Traversable RT?	N/A
N/A	Landing Length (in)	N/A	N/A	DWS Provided?	N/A
N/A	Landing Width (in)	N/A	N/A	DWS Contrast?	N/A
N/A	Landing Slope (%)	N/A	N/A	DWS Length (in)	N/A
N/A	Landing X Slope (%)	N/A	N/A	DWS Full Width?	N/A
N/A	Landing Curb? (Y/N)	N/A	N/A	DWS Offset (in)	N/A
N/A	Shared Landing?	N/A			
N/A	Gutter Ponding?	N/A	N/A	Gutter Slope (%)	N/A
N/A	Gutter Lip Ht (in)	N/A	N/A	Gutter X Slope (%)	N/A
N/A	Painted X Walk1?	No	N/A	Painted X Walk2?	N/A
	X Walk 1 Direction	To N		X Walk 2 Direction	N/A
N/A	X Walk 1 Width (in)	N/A	N/A	X Walk 2 Width (in)	N/A
	X Walk 1 Slope (%)	3.5		X Walk 2 Slope (%)	N/A
	X Walk 1 X Slope (%)	3.3		X Walk 2 X Slope (%)	N/A

**Remove & Replace Entire Ramp.**

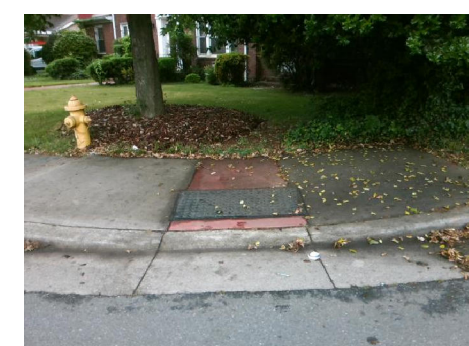
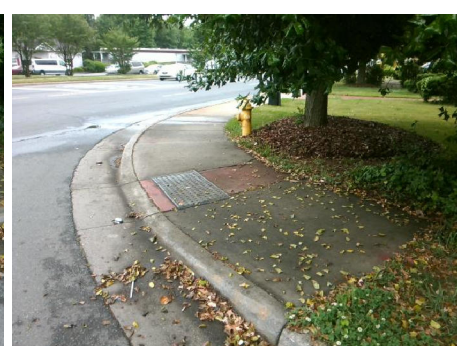
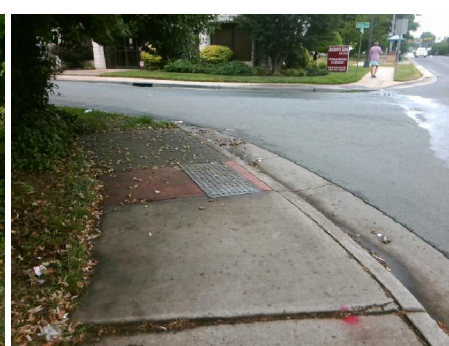
N/A	Ramp inside XWalk1?	N/A	N/A	Ramp inside XWalk2?	N/A
	Road Slope (%)	N/A	N/A	Clear Space?	N/A
	Road X Slope (%)	N/A	N/A	Clear Space to XWalk (in)	N/A
N/A	Any Obstructions?	N/A	N/A	Storm Grate/Utility Hazard?	N/A
	Obstruction Type			Storm Grate/Utility Type	
		N/A			N/A
			Yes	Surface Condition? (G/P)	Good
