Access Compliance Report

Public Rights-of-Way

(Curb Ramps)

Intersection ID: 53775	Main Street: STRAWBERRY_FIELDS_LN	Cross Street: CHAPECLANE_RD	Location: E
ADA ID: 93AD0BFD72DD	Ramp Type: Perp	Initial Pass/Fail: Fail	Overall Compliance: No
Severity Score: 12.5			
Codes/Mitigation Info/Possible Solution		Field Measurements/Component Compliance

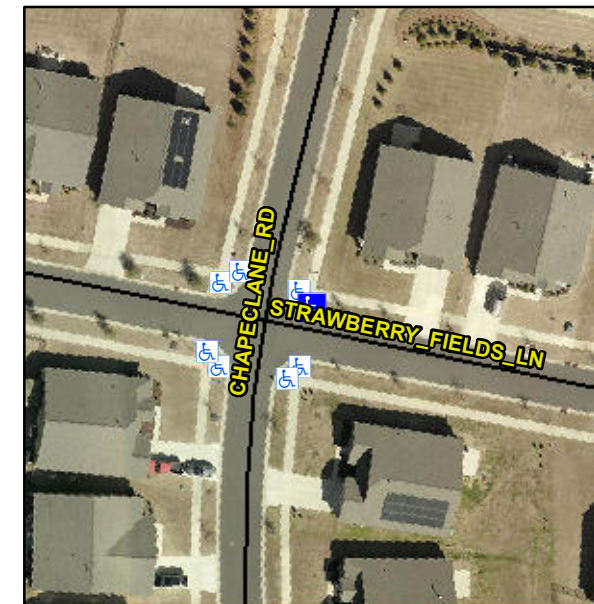
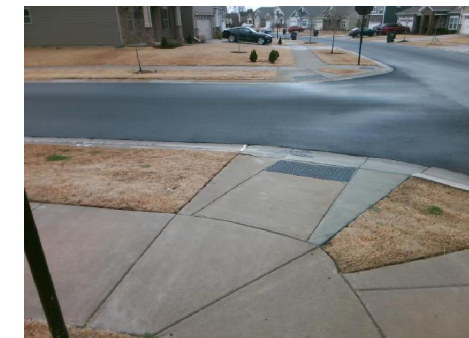
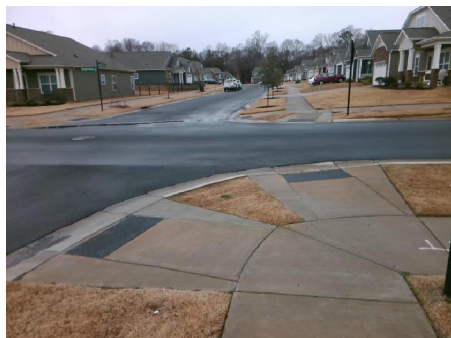
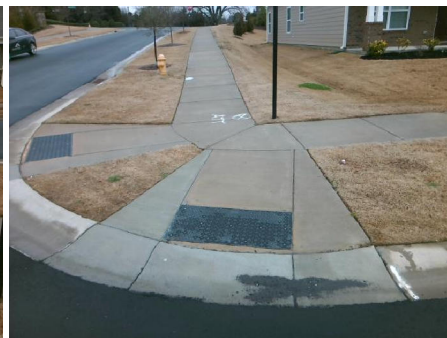
Not Found, R304.5.3

Compliance	Description	Data	Compliance	Description	Data
N/A	Ramp Length (in)	90.0	Yes	Ramp Slope (%)	7.7
Yes	Ramp Width (in)	48.0	No	Ramp XSlope (%)	5.2
N/A	Flare Type LT	N/A	N/A	Flare Type RT	N/A
N/A	Flare Slope LT (%)	N/A	N/A	Flare Slope RT (%)	N/A
N/A	Flare Traversable LT?	N/A	N/A	Flare Traversable RT?	N/A
N/A	Landing Length (in)	N/A	N/A	DWS Provided?	N/A
N/A	Landing Width (in)	N/A	N/A	DWS Contrast?	N/A
N/A	Landing Slope (%)	N/A	N/A	DWS Length (in)	N/A
N/A	Landing X Slope (%)	N/A	N/A	DWS Full Width?	N/A
N/A	Landing Curb? (Y/N)	N/A	N/A	DWS Offset (in)	N/A
N/A	Shared Landing?	N/A			
N/A	Gutter Ponding?	N/A	N/A	Gutter Slope (%)	N/A
N/A	Gutter Lip Ht (in)	N/A	N/A	Gutter X Slope (%)	N/A
N/A	Painted X Walk1?	No	N/A	Painted X Walk2?	N/A
	X Walk 1 Direction	To SW		X Walk 2 Direction	N/A
N/A	X Walk 1 Width (in)	N/A	N/A	X Walk 2 Width (in)	N/A
	X Walk 1 Slope (%)	2.2		X Walk 2 Slope (%)	N/A
	X Walk 1 X Slope (%)	1.2		X Walk 2 X Slope (%)	N/A

N/A	Ramp inside XWalk1?	N/A	N/A	Ramp inside XWalk2?	N/A
	Road Slope (%)	N/A	N/A	Clear Space?	N/A
	Road X Slope (%)	N/A	N/A	Clear Space to XWalk (in)	N/A
N/A	Any Obstructions?	N/A	N/A	Storm Grate/Utility Hazard?	N/A
	Obstruction Type			Storm Grate/Utility Type	
		N/A			N/A
			Yes	Surface Condition? (G/P)	Good

Remove & Replace Entire Ramp.

Total Cost: \$ 1850.00
