Access Compliance Report

Public Rights-of-Way

(Curb Ramps)

Intersection ID: 11628	Main Street: W_8TH_ST	Cross Street: N_PINE_ST	Location: E
ADA ID: 93B18D34D226	Ramp Type: PerpDiag	Initial Pass/Fail: Fail	Overall Compliance: No
		Severity Score: 37.5

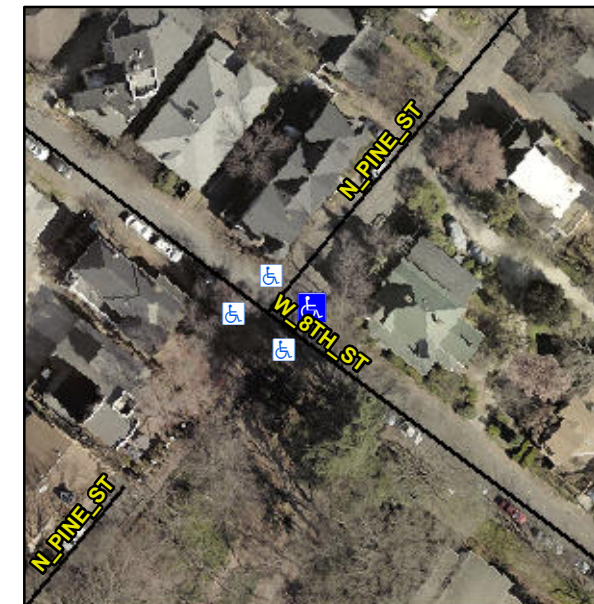
Not Found, R304.2.2, R304.5.3

Compliance	Description	Data	Compliance	Description	Data
N/A	Ramp Length (in)	52.0	No	Ramp Slope (%)	11.4
Yes	Ramp Width (in)	48.0	No	Ramp XSlope (%)	10.0
N/A	Flare Type LT	N/A	N/A	Flare Type RT	N/A
N/A	Flare Slope LT (%)	N/A	N/A	Flare Slope RT (%)	N/A
N/A	Flare Traversable LT?	N/A	N/A	Flare Traversable RT?	N/A
N/A	Landing Length (in)	N/A	N/A	DWS Provided?	N/A
N/A	Landing Width (in)	N/A	N/A	DWS Contrast?	N/A
N/A	Landing Slope (%)	N/A	N/A	DWS Length (in)	N/A
N/A	Landing X Slope (%)	N/A	N/A	DWS Full Width?	N/A
N/A	Landing Curb? (Y/N)	N/A	N/A	DWS Offset (in)	N/A
N/A	Shared Landing?	N/A			
N/A	Gutter Ponding?	N/A	N/A	Gutter Slope (%)	N/A
N/A	Gutter Lip Ht (in)	N/A	N/A	Gutter X Slope (%)	N/A
N/A	Painted X Walk1?	No	N/A	Painted X Walk2?	No
	X Walk 1 Direction	To NW		X Walk 2 Direction	To SW
N/A	X Walk 1 Width (in)	N/A	N/A	X Walk 2 Width (in)	N/A
	X Walk 1 Slope (%)	0.9		X Walk 2 Slope (%)	4.2
	X Walk 1 X Slope (%)	1.2		X Walk 2 X Slope (%)	2.3

N/A	Ramp inside XWalk1?	N/A	N/A	Ramp inside XWalk2?	N/A
	Road Slope (%)	1.2	N/A	Clear Space?	N/A
	Road X Slope (%)	4.4	N/A	Clear Space to XWalk (in)	N/A
N/A	Any Obstructions?	N/A	N/A	Storm Grate/Utility Hazard?	N/A
	Obstruction Type			Storm Grate/Utility Type	
		N/A			N/A
			Yes	Surface Condition? (G/P)	Good

Remove & Replace Curb Ramp With Two New Directional Ramps or Equivalent.

Total Cost: \$ 3200.00
