Access Compliance Report

Public Rights-of-Way

(Curb Ramps)

Intersection ID: 16072	Main Street: MONROE_RD	Cross Street: RICHLAND_DR	Location: NW
ADA ID: 93B75DE648AB	Ramp Type: Perp	Initial Pass/Fail: Fail	Overall Compliance: No
		Severity Score: 8.75

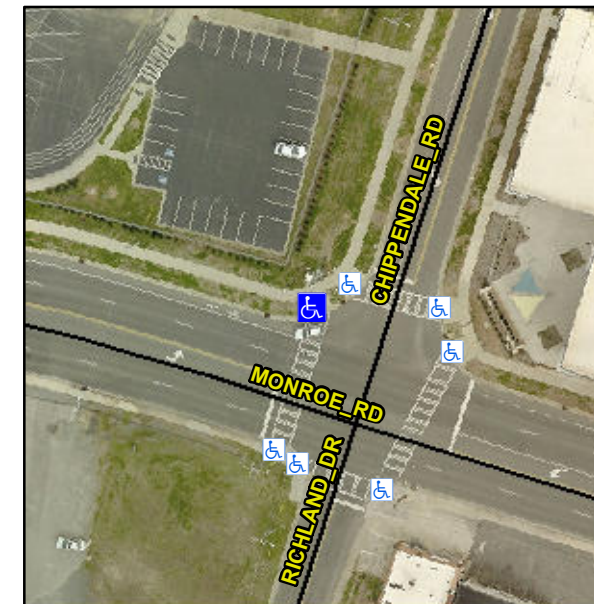
Not Found, R304.5.1

Compliance	Description	Data	Compliance	Description	Data
N/A	Ramp Length (in)	94.0	Yes	Ramp Slope (%)	6.2
No	Ramp Width (in)	46.5	Yes	Ramp XSlope (%)	0.3
N/A	Flare Type LT	N/A	N/A	Flare Type RT	N/A
N/A	Flare Slope LT (%)	N/A	N/A	Flare Slope RT (%)	N/A
N/A	Flare Traversable LT?	N/A	N/A	Flare Traversable RT?	N/A
N/A	Landing Length (in)	N/A	N/A	DWS Provided?	N/A
N/A	Landing Width (in)	N/A	N/A	DWS Contrast?	N/A
N/A	Landing Slope (%)	N/A	N/A	DWS Length (in)	N/A
N/A	Landing X Slope (%)	N/A	N/A	DWS Full Width?	N/A
N/A	Landing Curb? (Y/N)	N/A	N/A	DWS Offset (in)	N/A
N/A	Shared Landing?	N/A			
N/A	Gutter Ponding?	N/A	N/A	Gutter Slope (%)	N/A
N/A	Gutter Lip Ht (in)	N/A	N/A	Gutter X Slope (%)	N/A
N/A	Painted X Walk1?	Yes	N/A	Painted X Walk2?	N/A
	X Walk 1 Direction	To S		X Walk 2 Direction	N/A
N/A	X Walk 1 Width (in)	114.0	N/A	X Walk 2 Width (in)	N/A
	X Walk 1 Slope (%)	0.3		X Walk 2 Slope (%)	N/A
	X Walk 1 X Slope (%)	0.5		X Walk 2 X Slope (%)	N/A

N/A	Ramp inside XWalk1?	Yes	N/A	Ramp inside XWalk2?	N/A
	Road Slope (%)	N/A	N/A	Clear Space?	N/A
	Road X Slope (%)	N/A	N/A	Clear Space to XWalk (in)	N/A
N/A	Any Obstructions?	N/A	N/A	Storm Grate/Utility Hazard?	N/A
	Obstruction Type			Storm Grate/Utility Type	
		N/A			N/A
		Yes		Surface Condition? (G/P)	Good

Remove & Replace Entire Ramp.
