Access Compliance Report

Public Rights-of-Way

(Curb Ramps)

Intersection ID: N/A	Main Street: N COLLEGE ST	Cross Street: E 7TH ST	Location:	N
ADA ID: 93B82C343340	Ramp Type: Perp	Initial Pass/Fail: Fail	Overall Compliance: No	Severity Score: 25

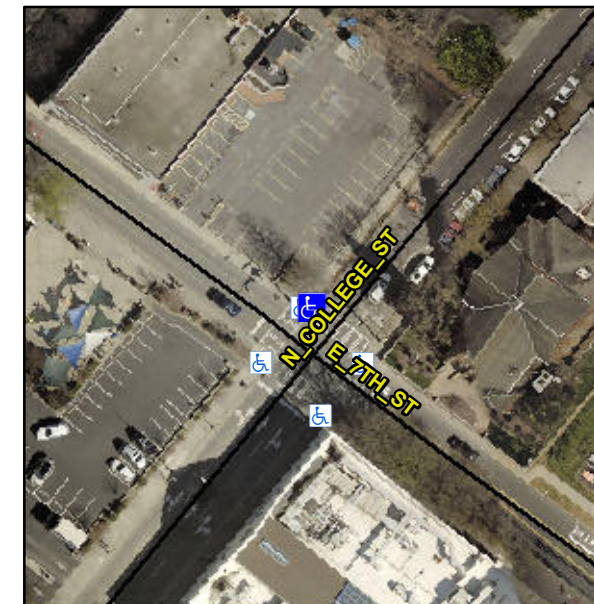
Not Found, R304.2.2

Compliance	Description	Data	Compliance	Description	Data
N/A	Ramp Length (in)	83.0	No	Ramp Slope (%)	12.9
Yes	Ramp Width (in)	66.0	Yes	Ramp XSlope (%)	0.4
N/A	Flare Type LT	N/A	N/A	Flare Type RT	N/A
N/A	Flare Slope LT (%)	N/A	N/A	Flare Slope RT (%)	N/A
N/A	Flare Traversable LT?	No	N/A	Flare Traversable RT?	No
N/A	Landing Length (in)	N/A	N/A	DWS Provided?	N/A
N/A	Landing Width (in)	N/A	N/A	DWS Contrast?	N/A
N/A	Landing Slope (%)	N/A	N/A	DWS Length (in)	N/A
N/A	Landing X Slope (%)	N/A	N/A	DWS Full Width?	N/A
N/A	Landing Curb? (Y/N)	N/A	N/A	DWS Offset (in)	N/A
N/A	Shared Landing?	N/A			
N/A	Gutter Ponding?	N/A	N/A	Gutter Slope (%)	N/A
N/A	Gutter Lip Ht (in)	N/A	N/A	Gutter X Slope (%)	N/A
N/A	Painted X Walk1?	Yes	N/A	Painted X Walk2?	N/A
	X Walk 1 Direction	To SE		X Walk 2 Direction	N/A
N/A	X Walk 1 Width (in)	110.0	N/A	X Walk 2 Width (in)	N/A
	X Walk 1 Slope (%)	4.5		X Walk 2 Slope (%)	N/A
	X Walk 1 X Slope (%)	5.7		X Walk 2 X Slope (%)	N/A

N/A	Ramp inside XWalk1?	Yes	N/A	Ramp inside XWalk2?	N/A
	Road Slope (%)	N/A	N/A	Clear Space?	N/A
	Road X Slope (%)	N/A	N/A	Clear Space to XWalk (in)	N/A
N/A	Any Obstructions?	N/A	N/A	Storm Grate/Utility Hazard?	N/A
	Obstruction Type			Storm Grate/Utility Type	
		N/A			N/A
			Yes	Surface Condition? (G/P)	Good

Remove & Replace Entire Ramp.
