# Access Compliance Report

## Public Rights-of-Way

### (Curb Ramps)

Intersection ID: 10933	Main Street: TUCKASEEGEE_RD	Cross Street: VANIZER_ST	Location: S
ADA ID: 93B8A82541D6	Ramp Type: Perp	Initial Pass/Fail: Fail	Overall Compliance: No
Severity Score: 8.75			
Codes/Mitigation Info/Possible Solution		Field Measurements/Component Compliance

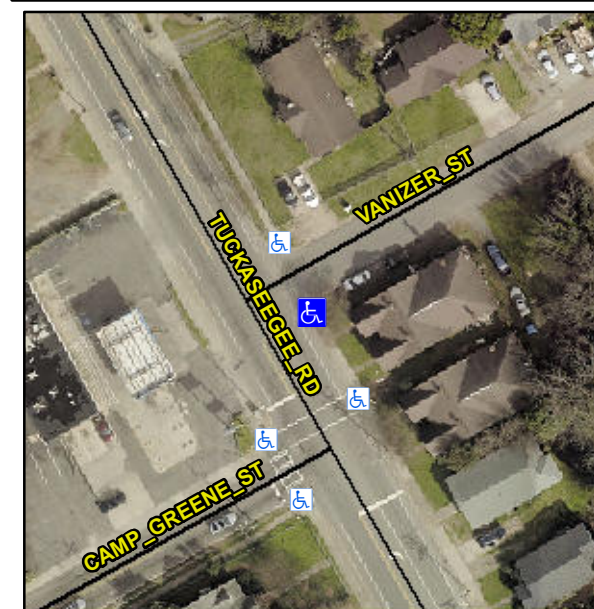
**Not Found, R304.5.1**

Compliance	Description	Data	Compliance	Description	Data
N/A	Ramp Length (in)	59.0	Yes	Ramp Slope (%)	7.0
No	Ramp Width (in)	47.5	Yes	Ramp XSlope (%)	0.9
N/A	Flare Type LT	N/A	N/A	Flare Type RT	N/A
N/A	Flare Slope LT (%)	N/A	N/A	Flare Slope RT (%)	N/A
N/A	Flare Traversable LT?	N/A	N/A	Flare Traversable RT?	N/A
N/A	Landing Length (in)	N/A	N/A	DWS Provided?	N/A
N/A	Landing Width (in)	N/A	N/A	DWS Contrast?	N/A
N/A	Landing Slope (%)	N/A	N/A	DWS Length (in)	N/A
N/A	Landing X Slope (%)	N/A	N/A	DWS Full Width?	N/A
N/A	Landing Curb? (Y/N)	N/A	N/A	DWS Offset (in)	N/A
N/A	Shared Landing?	N/A			
N/A	Gutter Ponding?	N/A	N/A	Gutter Slope (%)	N/A
N/A	Gutter Lip Ht (in)	N/A	N/A	Gutter X Slope (%)	N/A
N/A	Painted X Walk1?	No	N/A	Painted X Walk2?	N/A
	X Walk 1 Direction	To N		X Walk 2 Direction	N/A
N/A	X Walk 1 Width (in)	N/A	N/A	X Walk 2 Width (in)	N/A
	X Walk 1 Slope (%)	4.9		X Walk 2 Slope (%)	N/A
	X Walk 1 X Slope (%)	2.7		X Walk 2 X Slope (%)	N/A

N/A	Ramp inside XWalk1?	N/A	N/A	Ramp inside XWalk2?	N/A
	Road Slope (%)	N/A	N/A	Clear Space?	N/A
	Road X Slope (%)	N/A	N/A	Clear Space to XWalk (in)	N/A
N/A	Any Obstructions?	N/A	N/A	Storm Grate/Utility Hazard?	N/A
	Obstruction Type			Storm Grate/Utility Type	
		N/A			N/A
			Yes	Surface Condition? (G/P)	Good

**Remove & Replace Entire Ramp.**

Total Cost: \$ 1850.00
