# Access Compliance Report

## Public Rights-of-Way (Curb Ramps)

| Intersection ID: 25897 | Main Street: CASTLEKEEP_RD | Cross Street: TIMBERCREST_CR | Location: SE |
| ADA ID: 93E2787F1491 | Ramp Type: Directional1 | Initial Pass/Fail: Fail | Overall Compliance: No |

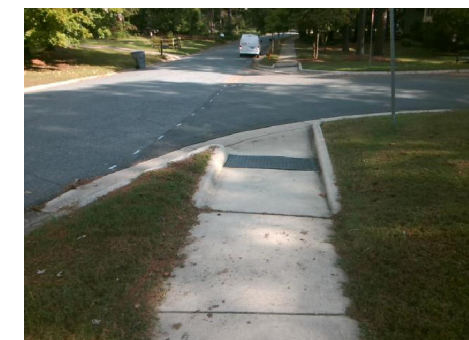
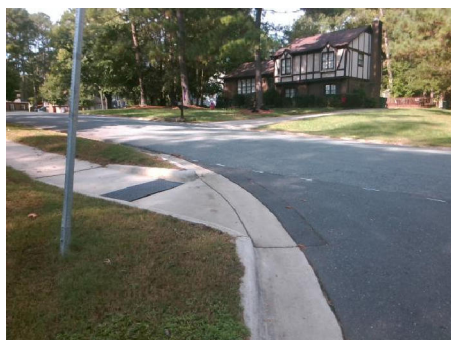
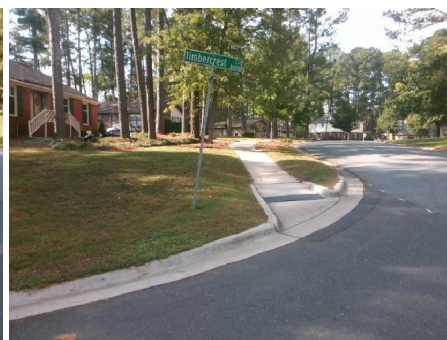
**R304.2.2, R304.5.3**

| Compliance | Description | Data | Compliance | Description | Data |
|---|---|---|---|---|---|
| No | Ramp Slope (%) | 10.8 | N/A | Grade Break XSlope (%) | 0.0 |
| No | Ramp XSlope (%) | 5.1 | | | |

**Remove & Replace Entire Ramp.**
