Access Compliance Report

Public Rights-of-Way

(Curb Ramps)

Intersection ID: 53890	Main Street: PUTNAM_PL	Cross Street: PAW_VALLEY_LN	Location: NE
ADA ID: 9411BF748354	Ramp Type: Perp	Initial Pass/Fail: Fail	Overall Compliance: No
Codes/Mitigation Info/Possible Solution		Field Measurements/Component Compliance

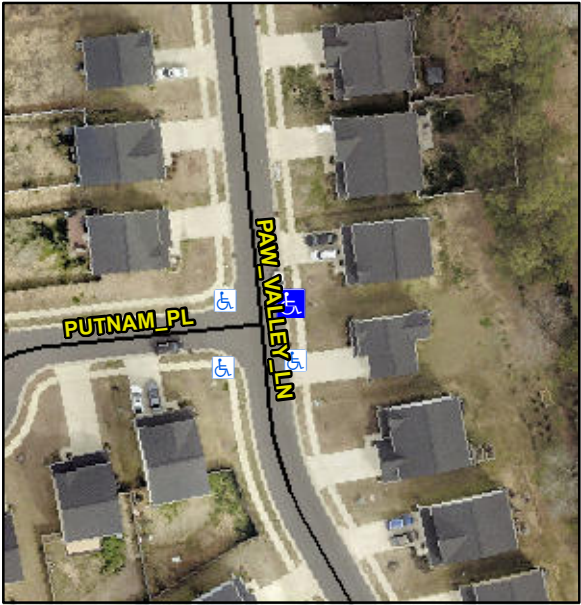
Possible Solutions:	Compliance	Description	Data	Compliance	Description	Data
	Remove & Replace Entire Ramp.	N/A	Ramp Length (in)	49.0	No	Ramp Slope (%)	9.5
		No	Ramp Width (in)	47.5	Yes	Ramp XSlope (%)	0.7
		N/A	Flare Type LT	N/A	N/A	Flare Type RT	N/A
		N/A	Flare Slope LT (%)	N/A	N/A	Flare Slope RT (%)	N/A
		N/A	Flare Traversable LT?	N/A	N/A	Flare Traversable RT?	N/A
		N/A	Landing Length (in)	N/A	N/A	DWS Provided?	N/A
		N/A	Landing Width (in)	N/A	N/A	DWS Contrast?	N/A
		N/A	Landing Slope (%)	N/A	N/A	DWS Length (in)	N/A
		N/A	Landing X Slope (%)	N/A	N/A	DWS Full Width?	N/A
		N/A	Landing Curb? (Y/N)	N/A	N/A	DWS Offset (in)	N/A
		N/A	Shared Landing?	N/A			
		N/A	Gutter Ponding?	N/A	N/A	Gutter Slope (%)	N/A
		N/A	Gutter Lip Ht (in)	N/A	N/A	Gutter X Slope (%)	N/A
		N/A	Painted X Walk1?	No	N/A	Painted X Walk2?	N/A
			X Walk 1 Direction	To W		X Walk 2 Direction	N/A
		N/A	X Walk 1 Width (in)	N/A	N/A	X Walk 2 Width (in)	N/A

X Walk 1 Slope (%)	3.5		X Walk 2 Slope (%)	N/A
			X Walk 1 X Slope (%)	1.4		X Walk 2 X Slope (%)	N/A
		N/A	Ramp inside XWalk1?	N/A	N/A	Ramp inside XWalk2?	N/A
<p>Surveyor Notes:</p> <p>N/A</p> <p>PROW/ADA:</p> <p>Not Found, R304.5.1, R304.2.2</p>			Road Slope (%)	N/A	N/A	Clear Space?	N/A
			Road X Slope (%)	N/A	N/A	Clear Space to XWalk (in)	N/A
		N/A	Any Obstructions?	N/A	N/A	Storm Grate/Utility Hazard?	N/A
			Obstruction Type			Storm Grate/Utility Type	
					N/A		N/A
					Yes	Surface Condition? (G/P)	Good
