# Access Compliance Report

## Public Rights-of-Way

### (Curb Ramps)

| Intersection ID: 10053 | Main Street: BURTON_ST | Cross Street: FONTANA_AV | Location: SW |

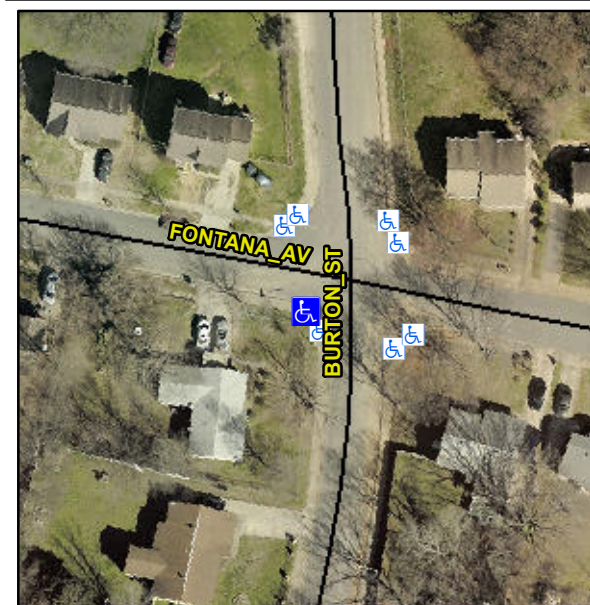
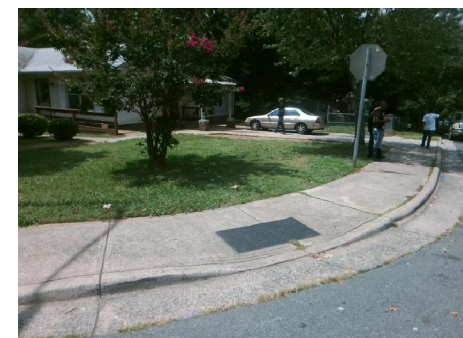
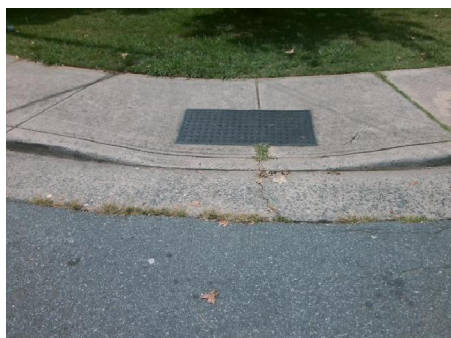
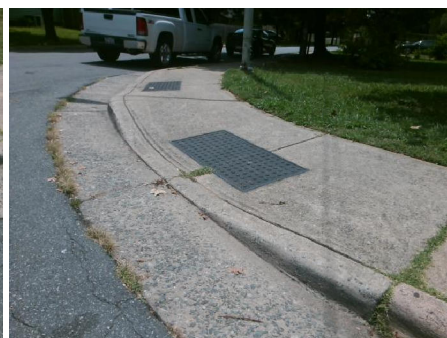
**Not Found, R304.2.1, R304.2.2-Perp,  
R304.3.2-Para, R304.5.3, R304.2.3,  
R305.1.4, R305.2, R302.7, R302.7.2,**

| Compliance | Description | Data | Compliance | Description | Data |
|---|---|---|---|---|---|
| No | Landing Length (in) | N/A | Yes | DWS Provided? | Yes |
| No | Landing Width (in) | N/A | Yes | DWS Contrast? | Yes |
| No | Landing Slope (%) | N/A | Yes | DWS Length (in) | 24.0 |
| No | Landing X Slope (%) | N/A | No | DWS Full Width? | No |
| N/A | Landing Curb? (Y/N) | No | No | DWS Offset (in) | 7.0 |
| No | Gutter Ponding? | Yes | No | Gutter Slope (%) | 9.0 |
| No | Gutter Lip Ht (in) | 1.0 | No | Gutter X Slope (%) | 3.0 |

**Remove & Replace Entire Ramp.  
Remove & Replace Gutter.**

Total Cost: \$ 2600.00
