Access Compliance Report

Public Rights-of-Way

(Curb Ramps)

Intersection ID: 25776	Main Street: CARMEL_COMMONS_BV	Cross Street: PINEVILLE-MATTHEWS_RD	Location: SW
ADA ID: 941718489427	Ramp Type: IslandPerp	Initial Pass/Fail: Fail	Overall Compliance: No
Severity Score: 33.75			
Codes/Mitigation Info/Possible Solution		Field Measurements/Component Compliance

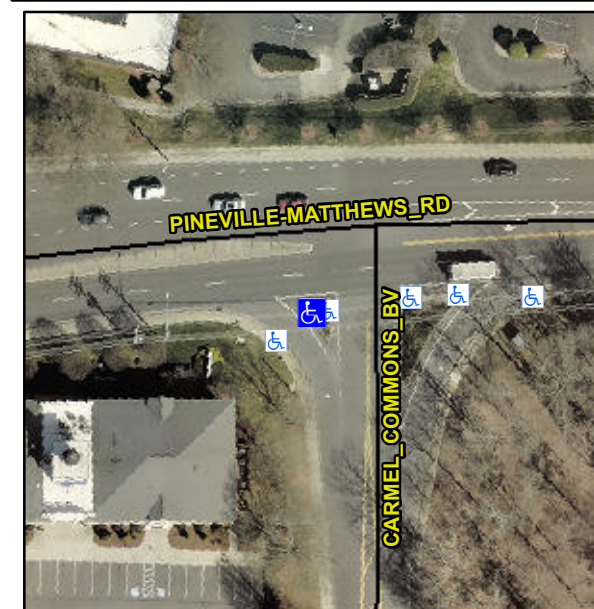
Not Found, R304.5.1, R304.2.2

Compliance	Description	Data	Compliance	Description	Data
N/A	Ramp Length (in)	43.0	No	Ramp Slope (%)	12.3
No	Ramp Width (in)	38.0	Yes	Ramp XSlope (%)	0.0
N/A	Flare Type LT	N/A	N/A	Flare Type RT	N/A
N/A	Flare Slope LT (%)	N/A	N/A	Flare Slope RT (%)	N/A
N/A	Flare Traversable LT?	N/A	N/A	Flare Traversable RT?	N/A
N/A	Landing Length (in)	N/A	N/A	DWS Provided?	N/A
N/A	Landing Width (in)	N/A	N/A	DWS Contrast?	N/A
N/A	Landing Slope (%)	N/A	N/A	DWS Length (in)	N/A
N/A	Landing X Slope (%)	N/A	N/A	DWS Full Width?	N/A
N/A	Landing Curb? (Y/N)	N/A	N/A	DWS Offset (in)	N/A
N/A	Shared Landing?	N/A			
N/A	Gutter Ponding?	N/A	N/A	Gutter Slope (%)	N/A
N/A	Gutter Lip Ht (in)	N/A	N/A	Gutter X Slope (%)	N/A
N/A	Painted X Walk1?	No	N/A	Painted X Walk2?	N/A
	X Walk 1 Direction	To W		X Walk 2 Direction	N/A
N/A	X Walk 1 Width (in)	N/A	N/A	X Walk 2 Width (in)	N/A
	X Walk 1 Slope (%)	1.3		X Walk 2 Slope (%)	N/A
	X Walk 1 X Slope (%)	1.3		X Walk 2 X Slope (%)	N/A

Remove & Replace Entire Ramp.

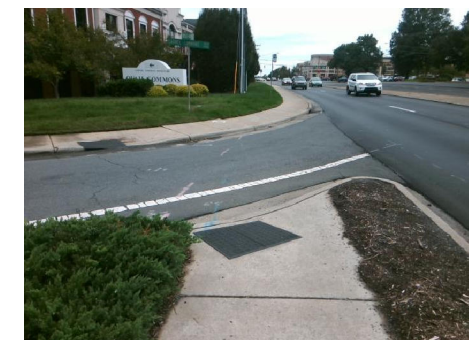
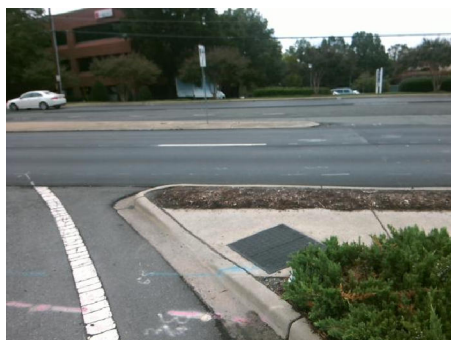
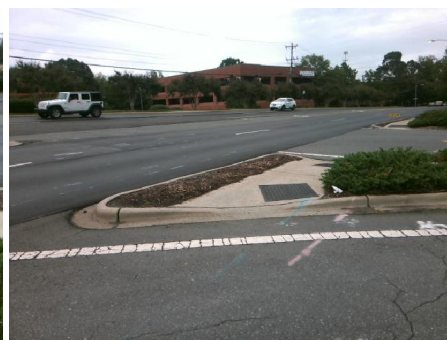
N/A	Ramp inside XWalk1?	N/A	N/A	Ramp inside XWalk2?	N/A
	Road Slope (%)	N/A	N/A	Clear Space?	N/A
	Road X Slope (%)	N/A	N/A	Clear Space to XWalk (in)	N/A
N/A	Any Obstructions?	N/A	N/A	Storm Grate/Utility Hazard?	N/A
	Obstruction Type			Storm Grate/Utility Type	
		N/A			N/A
			Yes	Surface Condition? (G/P)	Good
