Access Compliance Report

Public Rights-of-Way

(Curb Ramps)

Intersection ID: 11349	Main Street: N_DAVIDSON_ST	Cross Street: PARKWOOD_AV	Location: E
ADA ID: 94175BFC440C	Ramp Type: Perp	Initial Pass/Fail: Fail	Overall Compliance: No
Codes/Mitigation Info/Possible Solution		Field Measurements/Component Compliance

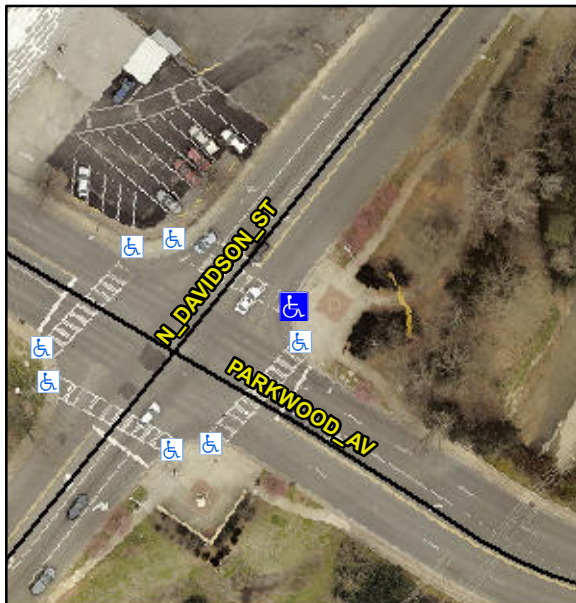
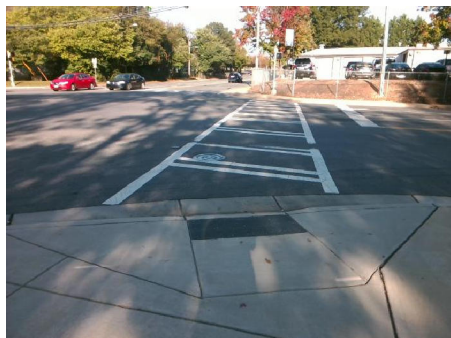
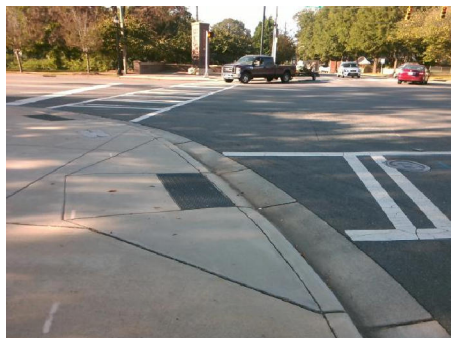
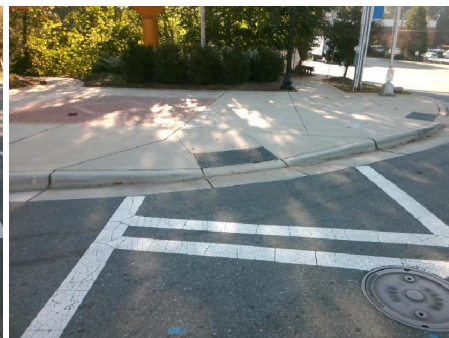
Not Found, R304.2.2, R304.5.3

Compliance	Description	Data	Compliance	Description	Data
N/A	Ramp Length (in)	65.0	No	Ramp Slope (%)	8.4
Yes	Ramp Width (in)	48.0	No	Ramp XSlope (%)	2.4
N/A	Flare Type LT	N/A	N/A	Flare Type RT	N/A
N/A	Flare Slope LT (%)	N/A	N/A	Flare Slope RT (%)	N/A
N/A	Flare Traversable LT?	N/A	N/A	Flare Traversable RT?	N/A
N/A	Landing Length (in)	N/A	N/A	DWS Provided?	N/A
N/A	Landing Width (in)	N/A	N/A	DWS Contrast?	N/A
N/A	Landing Slope (%)	N/A	N/A	DWS Length (in)	N/A
N/A	Landing X Slope (%)	N/A	N/A	DWS Full Width?	N/A
N/A	Landing Curb? (Y/N)	N/A	N/A	DWS Offset (in)	N/A
N/A	Shared Landing?	N/A			
N/A	Gutter Ponding?	N/A	N/A	Gutter Slope (%)	N/A
N/A	Gutter Lip Ht (in)	N/A	N/A	Gutter X Slope (%)	N/A
N/A	Painted X Walk1?	Yes	N/A	Painted X Walk2?	N/A
	X Walk 1 Direction	To NW		X Walk 2 Direction	N/A
N/A	X Walk 1 Width (in)	106.0	N/A	X Walk 2 Width (in)	N/A
	X Walk 1 Slope (%)	0.2		X Walk 2 Slope (%)	N/A
	X Walk 1 X Slope (%)	0.1		X Walk 2 X Slope (%)	N/A

N/A	Ramp inside XWalk1?	Yes	N/A	Ramp inside XWalk2?	N/A
	Road Slope (%)	N/A	N/A	Clear Space?	N/A
	Road X Slope (%)	N/A	N/A	Clear Space to XWalk (in)	N/A
N/A	Any Obstructions?	N/A	N/A	Storm Grate/Utility Hazard?	N/A
	Obstruction Type			Storm Grate/Utility Type	
		N/A			N/A
		Yes		Surface Condition? (G/P)	Good

Possible Solutions:

Remove & Replace Entire Ramp.
