Access Compliance Report Public Rights-of-Way (Curb Ramps)

Intersection ID: 15384 Main Street: EAST_BV Cross Street: GARDEN_TR Location: NE

ADA ID: 9417F6F578BB Ramp Type: PerpDiag Initial Pass/Fail: Fail Overall Compliance: No Severity Score: 13.75

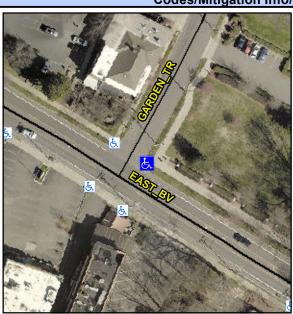
R304.2.2, R304.5.3

Field Measurements/Component Compliance					
Compliance Description		Data	Com	oliance Description	Data
N/A	A Ramp Length (in)	64.0	No	Ramp Slope (%)	9.4
Yes	Ramp Width (in)	64.0	No	Ramp XSlope (%)	3.8
N/A	Flare Type LT	N/A	N/A	Flare Type RT	N/A
N/A	Flare Slope LT (%)	N/A	N/A	Flare Slope RT (%)	N/A
N/A	Flare Traversable LT?	N/A	N/A	Flare Traversable RT?	N/A
N/A	Landing Length (in)	N/A	N/A	DWS Provided?	N/A
N/A	Landing Width (in)	N/A	N/A	DWS Contrast?	N/A
N/A	Landing Slope (%)	N/A	N/A	DWS Length (in)	N/A
N/A	Landing X Slope (%)	N/A	N/A	DWS Full Width?	N/A
N/A	Landing Curb? (Y/N)	N/A	N/A	DWS Offset (in)	N/A
N/A	A Shared Landing?	N/A			
N/A	A Gutter Ponding?	N/A	N/A	Gutter Slope (%)	N/A
N/A	Gutter Lip Ht (in)	N/A	N/A	Gutter X Slope (%)	N/A
N/A	A Painted X Walk1?	No	N/A	Painted X Walk2?	No
	X Walk 1 Direction	To NW		X Walk 2 Direction	To SW
N/A	X Walk 1 Width (in)	N/A	N/A	X Walk 2 Width (in)	N/A
	X Walk 1 Slope (%)	7.5		X Walk 2 Slope (%)	5.1

X Walk 1 X Slope (%)	1.4		X Walk 2 X Slope (%)	6.6
N/A	Ramp inside XWalk1?	N/A	N/A	Ramp inside XWalk2?	N/A
	Road Slope (%)	2.8	N/A	Clear Space?	N/A
	Road X Slope (%)	6.2	N/A	Clear Space to XWalk (in)	N/A
N/A	Any Obstructions?	N/A	N/A	Storm Grate/Utility Hazard?	N/A
	Obstruction Type			Storm Grate/Utility Type	
		N/A			N/A
			Yes	Surface Condition? (G/P)	Good
V	Albania Ch. Albania Ch. Co.

Remove & Replace Curb Ramp With
Two New Directional Ramps or
Equivalent.
