Access Compliance Report

Public Rights-of-Way

(Curb Ramps)

Intersection ID: 7570	Main Street: BEATTIES_FORD_RD	Cross Street: SIR_BAILEY_DR	Location: SE
ADA ID: 941FB5D6BA44	Ramp Type: Perp	Initial Pass/Fail: Fail	Overall Compliance: No
Severity Score: 22.5			
Codes/Mitigation Info/Possible Solution		Field Measurements/Component Compliance

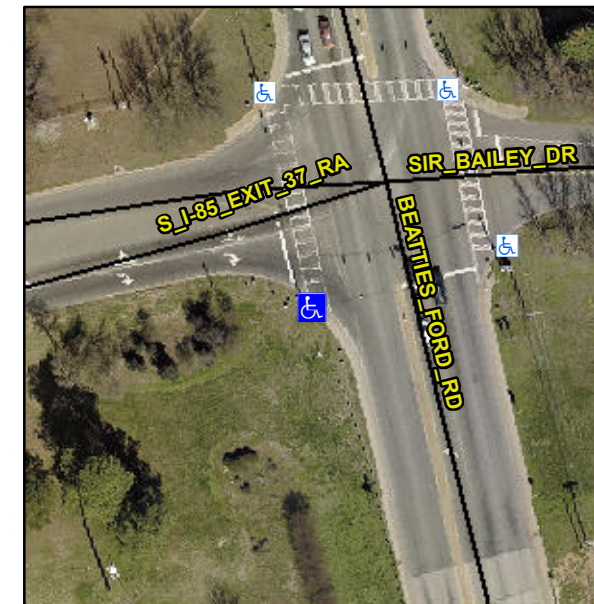
Compliance	Description	Data	Compliance	Description	Data
N/A	Ramp Length (in)	58.0	No	Ramp Slope (%)	9.0
No	Ramp Width (in)	38.0	No	Ramp XSlope (%)	4.5
N/A	Flare Type LT	N/A	N/A	Flare Type RT	N/A
N/A	Flare Slope LT (%)	N/A	N/A	Flare Slope RT (%)	N/A
N/A	Flare Traversable LT?	N/A	N/A	Flare Traversable RT?	N/A
N/A	Landing Length (in)	N/A	N/A	DWS Provided?	N/A
N/A	Landing Width (in)	N/A	N/A	DWS Contrast?	N/A
N/A	Landing Slope (%)	N/A	N/A	DWS Length (in)	N/A
N/A	Landing X Slope (%)	N/A	N/A	DWS Full Width?	N/A
N/A	Landing Curb? (Y/N)	N/A	N/A	DWS Offset (in)	N/A
N/A	Shared Landing?	N/A			
N/A	Gutter Ponding?	N/A	N/A	Gutter Slope (%)	N/A
N/A	Gutter Lip Ht (in)	N/A	N/A	Gutter X Slope (%)	N/A
N/A	Painted X Walk1?	Yes	N/A	Painted X Walk2?	N/A
	X Walk 1 Direction	To N		X Walk 2 Direction	N/A
N/A	X Walk 1 Width (in)	109.0	N/A	X Walk 2 Width (in)	N/A
	X Walk 1 Slope (%)	1.6		X Walk 2 Slope (%)	N/A
	X Walk 1 X Slope (%)	0.9		X Walk 2 X Slope (%)	N/A

N/A	Ramp inside XWalk1?	Yes	N/A	Ramp inside XWalk2?	N/A
	Road Slope (%)	N/A	N/A	Clear Space?	N/A
	Road X Slope (%)	N/A	N/A	Clear Space to XWalk (in)	N/A
N/A	Any Obstructions?	N/A	N/A	Storm Grate/Utility Hazard?	N/A
	Obstruction Type			Storm Grate/Utility Type	
		N/A			N/A
			Yes	Surface Condition? (G/P)	Good

Possible Solutions:

Remove & Replace Entire Ramp.
