# Access Compliance Report

## Public Rights-of-Way

### (Curb Ramps)

| Intersection ID: 49308 | Main Street: PANGLE_DR | Cross Street: JOSHUA_LN | Location: SW |

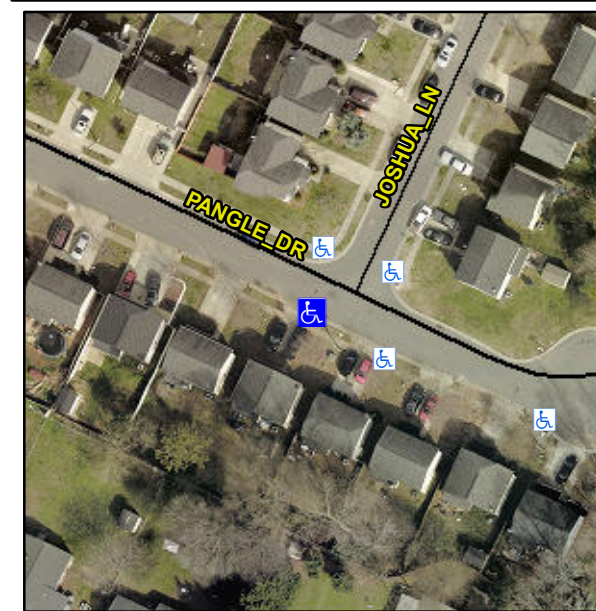
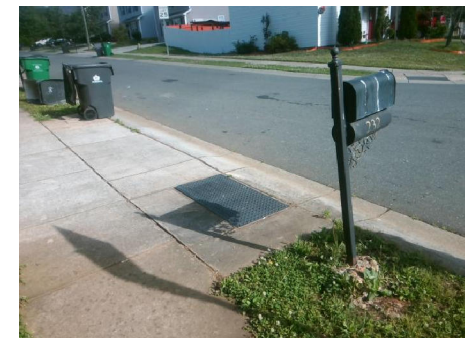
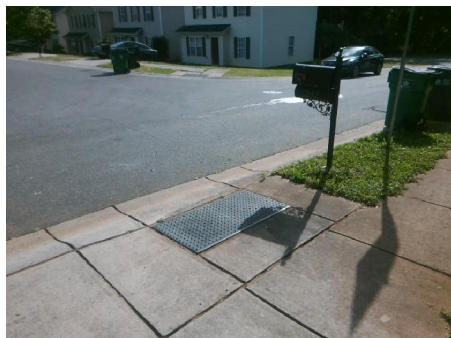
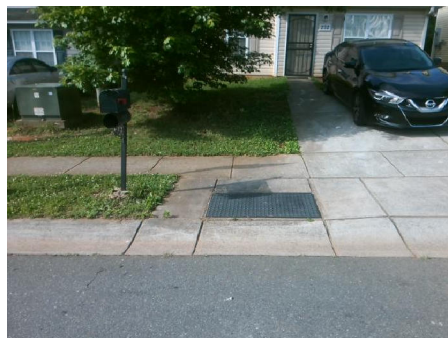
| ADA ID: 94276BB81545 | Ramp Type: BlendTrans1 | Initial Pass/Fail: Fail | Overall Compliance: No |
| Severity Score: 21.25 | | | |

**R304.5.1, R304.5.3**

| Compliance | Description | Data | Compliance | Description | Data |
|---|---|---|---|---|---|
| N/A | Ramp Length (in) | 46.0 | Yes | BlendTrans Slope (%) | 4.6 |
| No | Ramp Width (in) | 47.0 | No | BlendTrans XSlope (%) | 5.1 |

**Remove & Replace Curb Ramp With Two New Directional Ramps or Equivalent.**

Total Cost: \$ 3200.00
