Access Compliance Report

Public Rights-of-Way

(Curb Ramps)

Intersection ID: 44476	Main Street: LOYALIST_ST	Cross Street: WESTHOPE_ST	Location: E
ADA ID: 9429D04B934C	Ramp Type: BlendTrans1	Initial Pass/Fail: Fail	Overall Compliance: No
Severity Score: 8.75			
Codes/Mitigation Info/Possible Solution		Field Measurements/Component Compliance

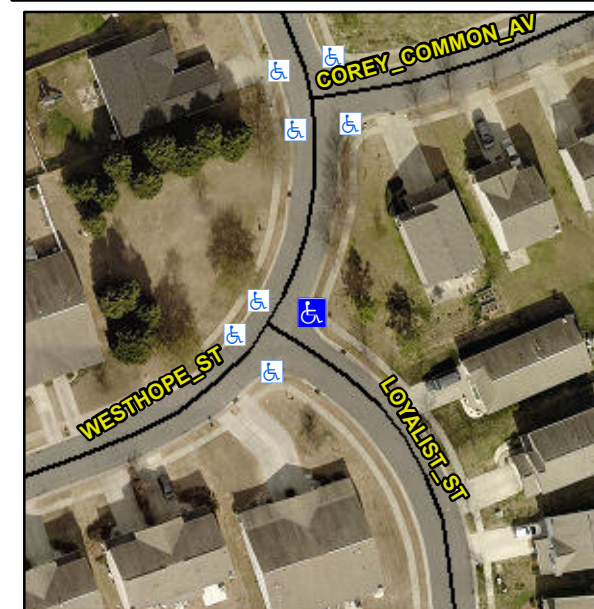
Compliance	Description	Data	Compliance	Description	Data
N/A	Ramp Length (in)	48.5	Yes	BlendTrans Slope (%)	1.6
No	Ramp Width (in)	47.5	Yes	BlendTrans XSlope (%)	1.7
N/A	Flare Type LT	N/A	N/A	Flare Type RT	N/A
N/A	Flare Slope LT (%)	N/A	N/A	Flare Slope RT (%)	N/A
N/A	Flare Traversable LT?	N/A	N/A	Flare Traversable RT?	N/A
N/A	Landing Length (in)	N/A	N/A	DWS Provided?	N/A
N/A	Landing Width (in)	N/A	N/A	DWS Contrast?	N/A
N/A	Landing Slope (%)	N/A	N/A	DWS Length (in)	N/A
N/A	Landing X Slope (%)	N/A	N/A	DWS Full Width?	N/A
N/A	Landing Curb? (Y/N)	N/A	N/A	DWS Offset (in)	N/A
N/A	Shared Landing?	N/A			
N/A	Gutter Ponding?	N/A	N/A	Gutter Slope (%)	N/A
N/A	Gutter Lip Ht (in)	N/A	N/A	Gutter X Slope (%)	N/A
N/A	Painted X Walk1?	No	N/A	Painted X Walk2?	No
	X Walk 1 Direction	To NW		X Walk 2 Direction	To SW
	X Walk 1 Width (in)	N/A		X Walk 2 Width (in)	N/A
	X Walk 1 Slope (%)	2.2		X Walk 2 Slope (%)	2.1
	X Walk 1 X Slope (%)	1.8		X Walk 2 X Slope (%)	0.2

N/A	Ramp inside XWalk1?	N/A	N/A	Ramp inside XWalk2?	N/A
	Road Slope (%)	1.6		Clear Space?	N/A
	Road X Slope (%)	3.8	N/A	Clear Space to XWalk (in)	N/A
N/A	Any Obstructions?	N/A	N/A	Storm Grate/Utility Hazard?	N/A
	Obstruction Type			Storm Grate/Utility Type	
		N/A			N/A
			Yes	Surface Condition? (G/P)	Good
			No	Curb Slope (%)	11.8

Possible Solutions:

Remove & Replace Curb Ramp With Two New Directional Ramps or Equivalent.
