Access Compliance Report

Public Rights-of-Way

(Curb Ramps)

Intersection ID: 46916	Main Street: SHORTLEAF_PINE_CT	Cross Street: PONDEROSA_PINE_LN	Location: E
ADA ID: 942AA33FD1CE	Ramp Type: Perp	Initial Pass/Fail: Pass	Overall Compliance: No
Severity Score: 5.25			
Codes/Mitigation Info/Possible Solution		Field Measurements/Component Compliance

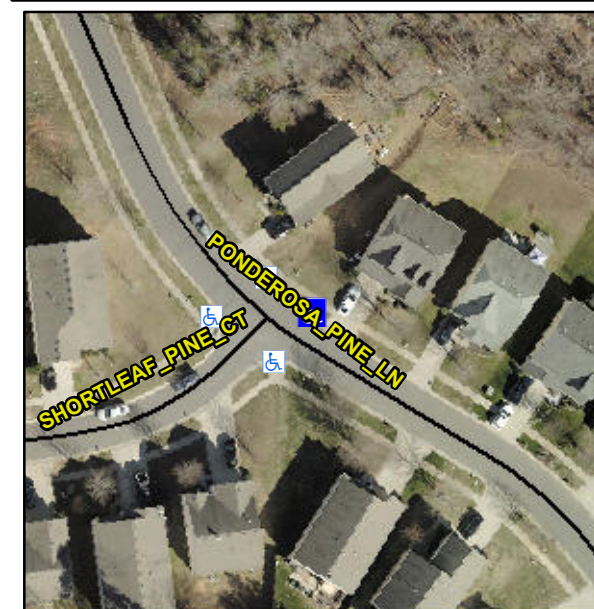
Not Found, R304.5.3, R304.5.4

Possible Solutions:

**Remove & Replace Entire Ramp.
Remove & Replace Gutter.**

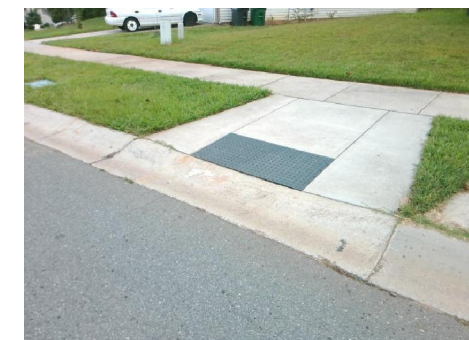
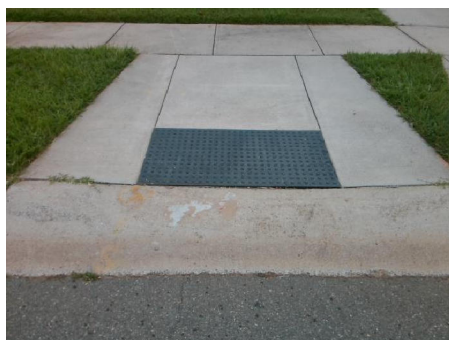
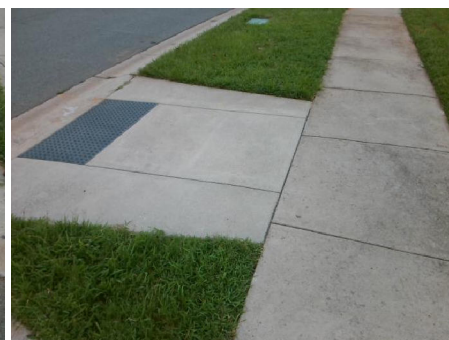
Compliance	Description	Data	Compliance	Description	Data
N/A	Ramp Length (in)	84.0	Yes	Ramp Slope (%)	6.6
Yes	Ramp Width (in)	48.0	Yes	Ramp XSlope (%)	2.4
N/A	Flare Type LT	Sloped	N/A	Flare Type RT	N/A
N/A	Flare Slope LT (%)	1.6	N/A	Flare Slope RT (%)	8.3
N/A	Flare Traversable LT?	No	N/A	Flare Traversable RT?	No
Yes	Landing Length (in)	48.0	Yes	DWS Provided?	Yes
Yes	Landing Width (in)	48.0	Yes	DWS Contrast?	Yes
Yes	Landing Slope (%)	1.7	Yes	DWS Length (in)	24.5
No	Landing X Slope (%)	4.0	Yes	DWS Full Width?	Yes
N/A	Landing Curb? (Y/N)	No	Yes	DWS Offset (in)	0.0
N/A	Shared Landing?	No			
Yes	Gutter Ponding?	No	No	Gutter Slope (%)	5.9
Yes	Gutter Lip Ht (in)	0.0	Yes	Gutter X Slope (%)	3.1
N/A	Painted X Walk1?	No	N/A	Painted X Walk2?	N/A
	X Walk 1 Direction	To NW		X Walk 2 Direction	N/A
N/A	X Walk 1 Width (in)	N/A	N/A	X Walk 2 Width (in)	N/A
	X Walk 1 Slope (%)	2.4		X Walk 2 Slope (%)	N/A
	X Walk 1 X Slope (%)	3.5		X Walk 2 X Slope (%)	N/A

N/A	Ramp inside XWalk1?	N/A	N/A	Ramp inside XWalk2?	N/A
	Road Slope (%)	N/A	N/A	Clear Space?	Yes
	Road X Slope (%)	N/A	N/A	Clear Space to XWalk (in)	N/A
Yes	Any Obstructions?	No	Yes	Storm Grate/Utility Hazard?	No
	Obstruction Type			Storm Grate/Utility Type	
		N/A			N/A
			Yes	Surface Condition? (G/P)	Good
