Access Compliance Report

Public Rights-of-Way

(Curb Ramps)

Intersection ID: 47457	Main Street: STEELE_CREEK_RD	Cross Street: WINGED_TEAL_RD	Location: SE
ADA ID: 94410FD17FD7	Ramp Type: Perp	Initial Pass/Fail: Fail	Overall Compliance: No
Severity Score: 22.5			
Codes/Mitigation Info/Possible Solution		Field Measurements/Component Compliance

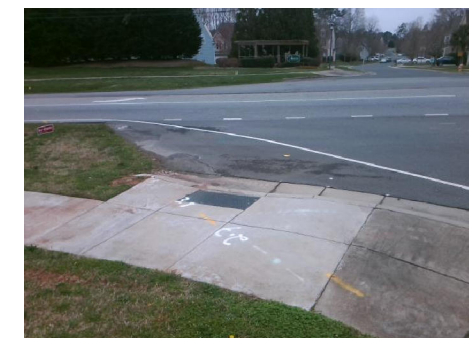
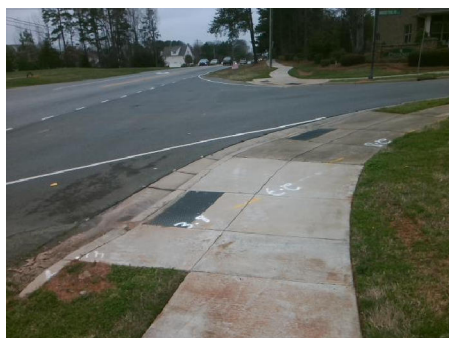
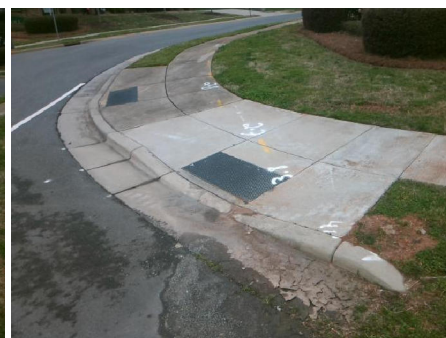
Compliance	Description	Data	Compliance	Description	Data
N/A	Ramp Length (in)	48.0	No	Ramp Slope (%)	10.4
No	Ramp Width (in)	46.0	Yes	Ramp XSlope (%)	2.4
N/A	Flare Type LT	N/A	N/A	Flare Type RT	N/A
N/A	Flare Slope LT (%)	N/A	N/A	Flare Slope RT (%)	N/A
N/A	Flare Traversable LT?	N/A	N/A	Flare Traversable RT?	N/A
N/A	Landing Length (in)	N/A	N/A	DWS Provided?	N/A
N/A	Landing Width (in)	N/A	N/A	DWS Contrast?	N/A
N/A	Landing Slope (%)	N/A	N/A	DWS Length (in)	N/A
N/A	Landing X Slope (%)	N/A	N/A	DWS Full Width?	N/A
N/A	Landing Curb? (Y/N)	N/A	N/A	DWS Offset (in)	N/A
N/A	Shared Landing?	N/A			
N/A	Gutter Ponding?	N/A	N/A	Gutter Slope (%)	N/A
N/A	Gutter Lip Ht (in)	N/A	N/A	Gutter X Slope (%)	N/A
N/A	Painted X Walk1?	No	N/A	Painted X Walk2?	N/A
	X Walk 1 Direction	To SW		X Walk 2 Direction	N/A
N/A	X Walk 1 Width (in)	N/A	N/A	X Walk 2 Width (in)	N/A
	X Walk 1 Slope (%)	2.9		X Walk 2 Slope (%)	N/A
	X Walk 1 X Slope (%)	3.4		X Walk 2 X Slope (%)	N/A

N/A	Ramp inside XWalk1?	N/A	N/A	Ramp inside XWalk2?	N/A
	Road Slope (%)	N/A	N/A	Clear Space?	N/A
	Road X Slope (%)	N/A	N/A	Clear Space to XWalk (in)	N/A
N/A	Any Obstructions?	N/A	N/A	Storm Grate/Utility Hazard?	N/A
	Obstruction Type			Storm Grate/Utility Type	
		N/A			N/A
			Yes	Surface Condition? (G/P)	Good

Possible Solutions:

Remove & Replace Entire Ramp.
