# Access Compliance Report

## Public Rights-of-Way

### (Curb Ramps)

| Intersection ID: 42362 | Main Street: OSPREY_KNOLL_DR | Cross Street: HERON_GLEN_DR | Location: | N |

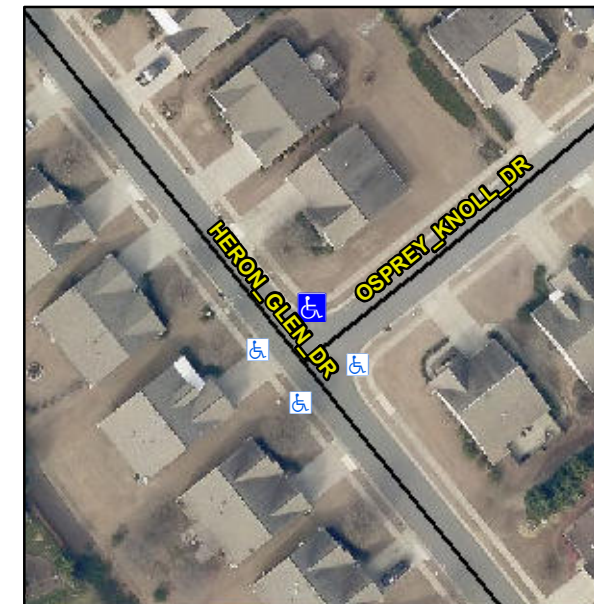
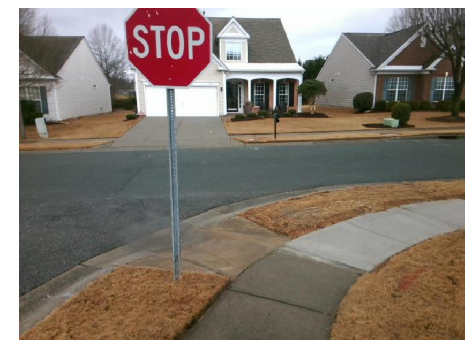
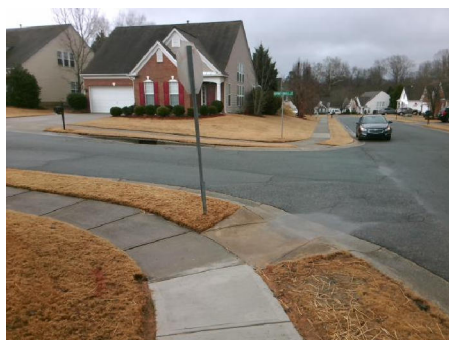
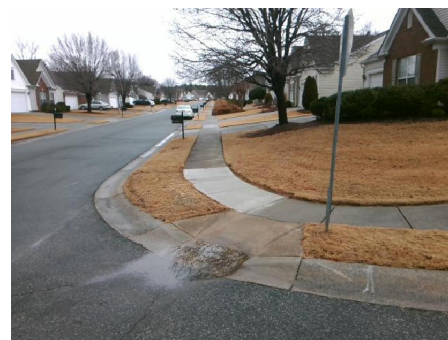
| ADA ID: 945111BDC94D | Ramp Type: BlendTrans1 | Initial Pass/Fail: Fail | Overall Compliance: No | Severity Score: 8.75 |

**R304.5.1**

| Compliance | Description | Data | Compliance | Description | Data |
|---|---|---|---|---|---|
| No | Ramp Width (in) | 39.0 | Yes | BlendTrans XSlope (%) | 1.1 |
| N/A | Gutter Ponding? | Yes | N/A | Gutter Slope (%) | N/A |

**Remove & Replace Curb Ramp With Two New Directional Ramps or Equivalent.**

Total Cost: \$ 3200.00
