Access Compliance Report

Public Rights-of-Way

(Curb Ramps)

Intersection ID: 16126	Main Street: E_W_T_HARRIS_BV	Cross Street: IDLEWILD_RD	Location: SW
ADA ID: 9456A3DF30F2	Ramp Type: PerpDiag	Initial Pass/Fail: Fail	Overall Compliance: No
Severity Score: 12.5			
Codes/Mitigation Info/Possible Solution		Field Measurements/Component Compliance

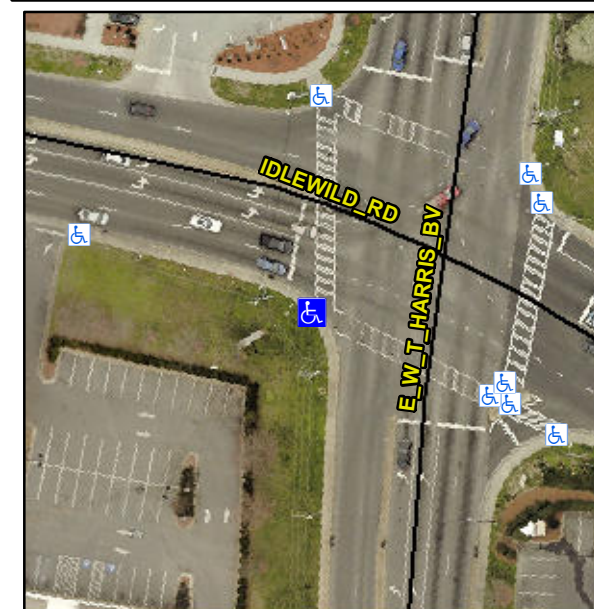
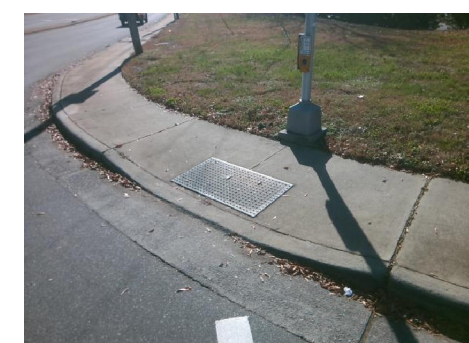
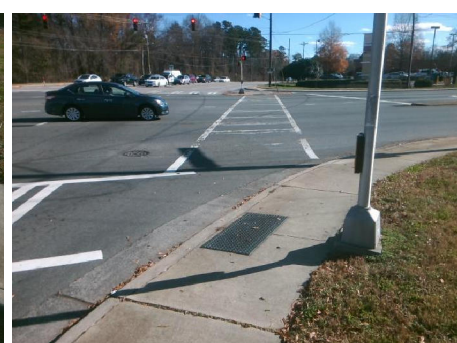
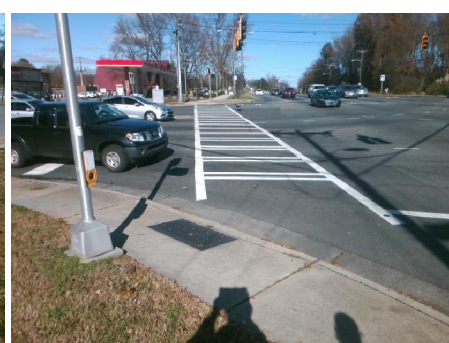
Compliance	Description	Data	Compliance	Description	Data
N/A	Ramp Length (in)	60.0	No	Ramp Slope (%)	9.7
Yes	Ramp Width (in)	48.0	Yes	Ramp XSlope (%)	0.2
N/A	Flare Type LT	N/A	N/A	Flare Type RT	N/A
N/A	Flare Slope LT (%)	N/A	N/A	Flare Slope RT (%)	N/A
N/A	Flare Traversable LT?	N/A	N/A	Flare Traversable RT?	N/A
N/A	Landing Length (in)	N/A	N/A	DWS Provided?	N/A
N/A	Landing Width (in)	N/A	N/A	DWS Contrast?	N/A
N/A	Landing Slope (%)	N/A	N/A	DWS Length (in)	N/A
N/A	Landing X Slope (%)	N/A	N/A	DWS Full Width?	N/A
N/A	Landing Curb? (Y/N)	N/A	N/A	DWS Offset (in)	N/A
N/A	Shared Landing?	N/A			
N/A	Gutter Ponding?	N/A	N/A	Gutter Slope (%)	N/A
N/A	Gutter Lip Ht (in)	1.0	N/A	Gutter X Slope (%)	N/A
N/A	Painted X Walk1?	Yes	N/A	Painted X Walk2?	Yes
	X Walk 1 Direction	To SE		X Walk 2 Direction	To NE
N/A	X Walk 1 Width (in)	121.0	N/A	X Walk 2 Width (in)	107.0
	X Walk 1 Slope (%)	2.8		X Walk 2 Slope (%)	4.5
	X Walk 1 X Slope (%)	5.5		X Walk 2 X Slope (%)	4.5

N/A	Ramp inside XWalk1?	Yes	N/A	Ramp inside XWalk2?	No
	Road Slope (%)	0.1	N/A	Clear Space?	N/A
	Road X Slope (%)	6.9	N/A	Clear Space to XWalk (in)	N/A
N/A	Any Obstructions?	N/A	N/A	Storm Grate/Utility Hazard?	N/A
	Obstruction Type			Storm Grate/Utility Type	
		N/A			N/A
		Yes		Surface Condition? (G/P)	Good

Possible Solutions:

Remove & Replace Curb Ramp With Two New Directional Ramps or Equivalent. Restripe Crosswalk.

R304.2.2
