# Access Compliance Report

## Public Rights-of-Way

### (Curb Ramps)

Intersection ID: 18818	Main Street: BEAM_RD	Cross Street: SHOPTON_RD	Location: SE
ADA ID: 9456F88766AD	Ramp Type: Perp	Initial Pass/Fail: Fail	Overall Compliance: No
Severity Score: 12.5			
Codes/Mitigation Info/Possible Solution		Field Measurements/Component Compliance

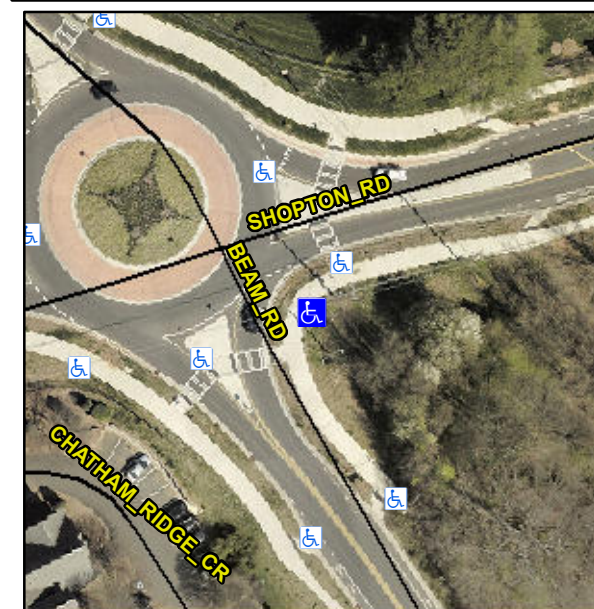
Compliance	Description	Data	Compliance	Description	Data
N/A	Ramp Length (in)	94.0	Yes	Ramp Slope (%)	5.4
Yes	Ramp Width (in)	95.0	No	Ramp XSlope (%)	6.9
N/A	Flare Type LT	N/A	N/A	Flare Type RT	N/A
N/A	Flare Slope LT (%)	N/A	N/A	Flare Slope RT (%)	N/A
N/A	Flare Traversable LT?	N/A	N/A	Flare Traversable RT?	N/A
N/A	Landing Length (in)	N/A	N/A	DWS Provided?	N/A
N/A	Landing Width (in)	N/A	N/A	DWS Contrast?	N/A
N/A	Landing Slope (%)	N/A	N/A	DWS Length (in)	N/A
N/A	Landing X Slope (%)	N/A	N/A	DWS Full Width?	N/A
N/A	Landing Curb? (Y/N)	N/A	N/A	DWS Offset (in)	N/A
N/A	Shared Landing?	N/A			
N/A	Gutter Ponding?	N/A	N/A	Gutter Slope (%)	N/A
N/A	Gutter Lip Ht (in)	N/A	N/A	Gutter X Slope (%)	N/A
N/A	Painted X Walk1?	Yes	N/A	Painted X Walk2?	N/A
	X Walk 1 Direction	To W		X Walk 2 Direction	N/A
N/A	X Walk 1 Width (in)	112.0	N/A	X Walk 2 Width (in)	N/A
	X Walk 1 Slope (%)	2.6		X Walk 2 Slope (%)	N/A
	X Walk 1 X Slope (%)	3.3		X Walk 2 X Slope (%)	N/A

N/A	Ramp inside XWalk1?	Yes	N/A	Ramp inside XWalk2?	N/A
	Road Slope (%)	N/A	N/A	Clear Space?	N/A
	Road X Slope (%)	N/A	N/A	Clear Space to XWalk (in)	N/A
N/A	Any Obstructions?	N/A	N/A	Storm Grate/Utility Hazard?	N/A
	Obstruction Type			Storm Grate/Utility Type	
		N/A			N/A
		Yes		Surface Condition? (G/P)	Good

**Remove & Replace Entire Ramp.**

**R304.5.3**

**\$ 1850.00**
