Access Compliance Report Public Rights-of-Way (Curb Ramps)

Intersection ID: 13301 Main Street: S_TRYON_ST Cross Street: W_CATHERINE_ST Location: S

ADA ID: 945A6B376CEA Ramp Type: Perp Initial Pass/Fail: Fail Overall Compliance: No Severity Score: 13.75

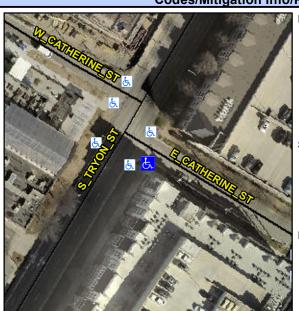
10.1

2.1

Ramp Slope (%)

Ramp XSlope (%)

Not Found, R304.2.2, R304.5.3

Possible Solutions:

Remove & Replace Entire Ramp.

N/A
Total Cost:
\$ 1850.00
