Access Compliance Report

Public Rights-of-Way

(Curb Ramps)

Intersection ID: 47876	Main Street: MARYANNA_CT	Cross Street: WOODSORREL_LN	Location: W
ADA ID: 945C3B2E3BB8	Ramp Type: PerpDiag	Initial Pass/Fail: Fail	Overall Compliance: No
Severity Score: 10			
Codes/Mitigation Info/Possible Solution		Field Measurements/Component Compliance

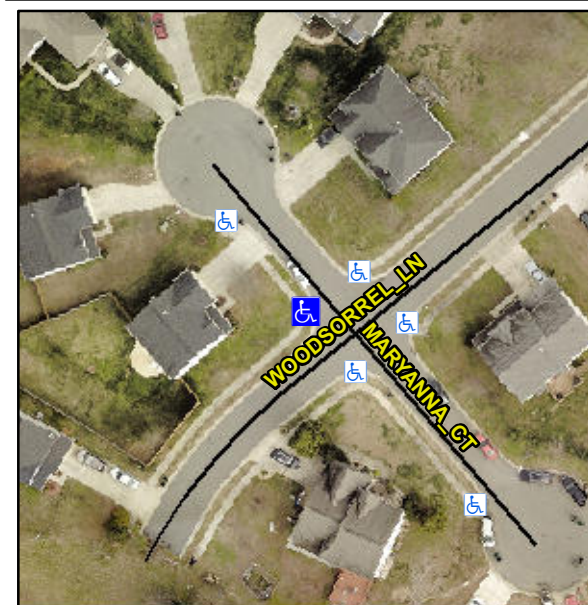
PROW/ADA:

Not Found, R304.5.1, R304.5.3

Compliance	Description	Data	Compliance	Description	Data
N/A	Ramp Length (in)	48.0	Yes	Ramp Slope (%)	5.0
No	Ramp Width (in)	43.0	No	Ramp XSlope (%)	5.0
N/A	Flare Type LT	N/A	N/A	Flare Type RT	N/A
N/A	Flare Slope LT (%)	N/A	N/A	Flare Slope RT (%)	N/A
N/A	Flare Traversable LT?	N/A	N/A	Flare Traversable RT?	N/A
N/A	Landing Length (in)	N/A	N/A	DWS Provided?	N/A
N/A	Landing Width (in)	N/A	N/A	DWS Contrast?	N/A
N/A	Landing Slope (%)	N/A	N/A	DWS Length (in)	N/A
N/A	Landing X Slope (%)	N/A	N/A	DWS Full Width?	N/A
N/A	Landing Curb? (Y/N)	N/A	N/A	DWS Offset (in)	N/A
N/A	Shared Landing?	N/A			
N/A	Gutter Ponding?	N/A	N/A	Gutter Slope (%)	N/A
N/A	Gutter Lip Ht (in)	N/A	N/A	Gutter X Slope (%)	N/A
N/A	Painted X Walk1?	No	N/A	Painted X Walk2?	No
	X Walk 1 Direction	To SE		X Walk 2 Direction	To NE
N/A	X Walk 1 Width (in)	N/A	N/A	X Walk 2 Width (in)	N/A
	X Walk 1 Slope (%)	3.1		X Walk 2 Slope (%)	3.3
	X Walk 1 X Slope (%)	5.8		X Walk 2 X Slope (%)	0.3

N/A	Ramp inside XWalk1?	N/A	N/A	Ramp inside XWalk2?	N/A
	Road Slope (%)	3.1	N/A	Clear Space?	N/A
	Road X Slope (%)	2.6	N/A	Clear Space to XWalk (in)	N/A
N/A	Any Obstructions?	N/A	N/A	Storm Grate/Utility Hazard?	N/A
	Obstruction Type			Storm Grate/Utility Type	
		N/A			N/A
			Yes	Surface Condition? (G/P)	Good

Possible Solutions:

Remove & Replace Curb Ramp With Two New Directional Ramps or Equivalent.
